# Asbestos Reinspection Survey Report Nutfield Church Primary School 59 Midstreet South Nutfield

Carried out on behalf of Surrey County Council by Tetra Tech EPT Ltd

J065222(1) 784-B047725  
Survey Date: 31 Aug 2023  
Report Issued: 6 Sep 2023

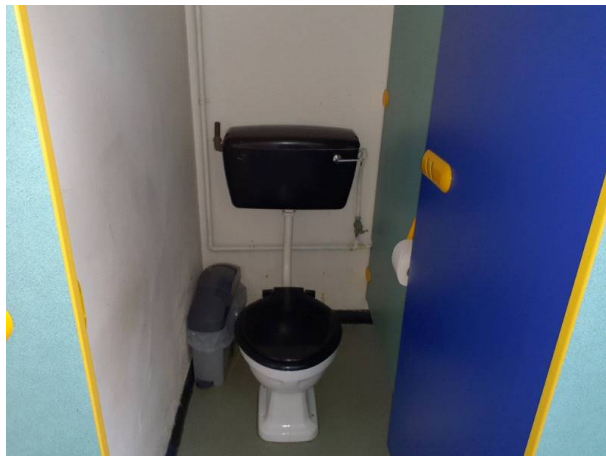
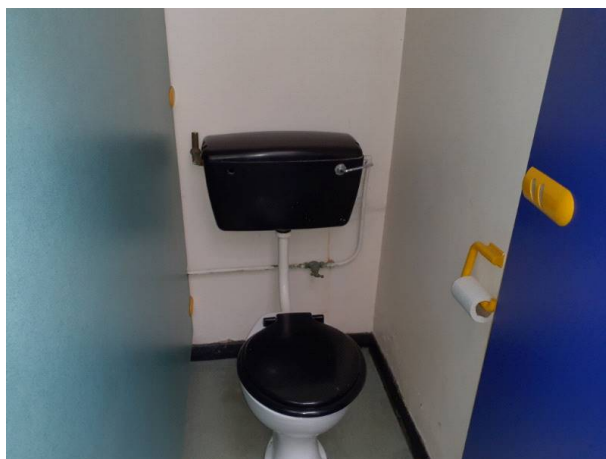
**Item Notes** No sample ref 6 - Strongly Presumed.  
No Change

| Extent of Damage | 1 |

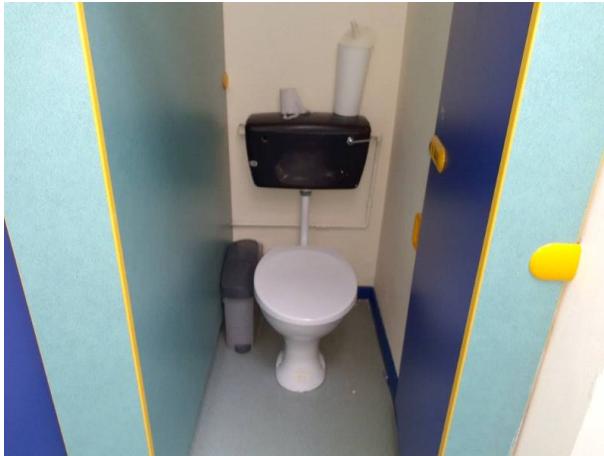
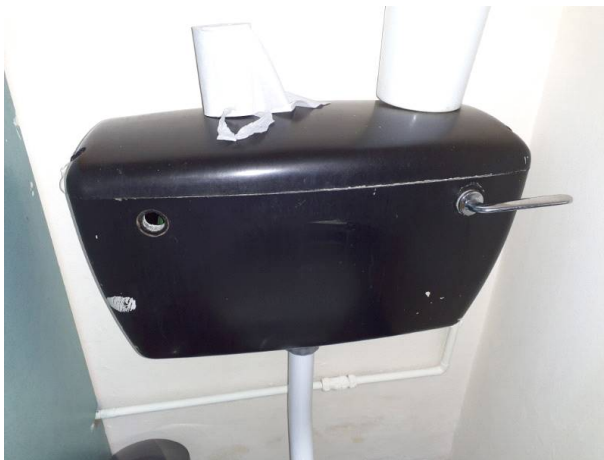
Item Notes No Change

| Extent of Damage | 1 |

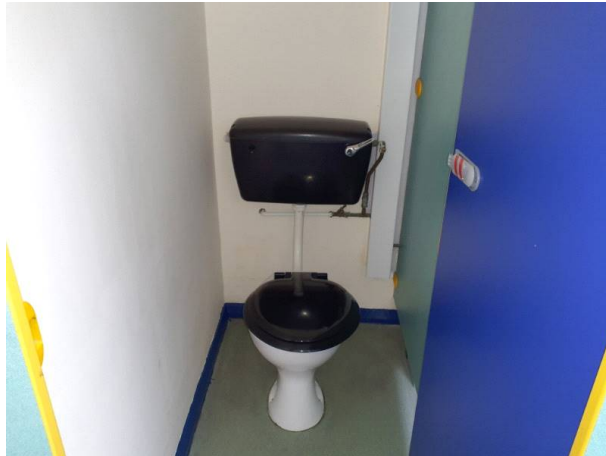
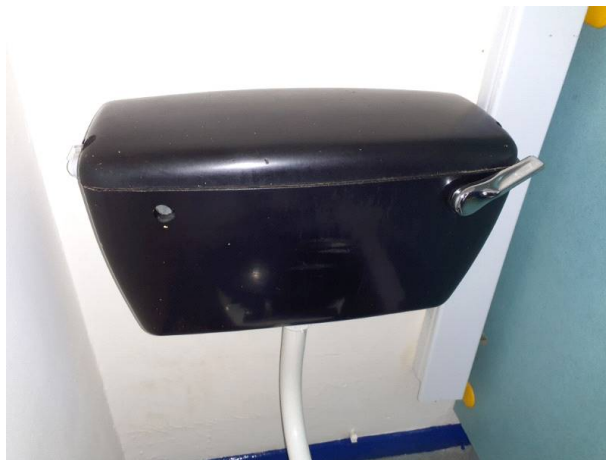
**Item Notes** No sample ref 2 - Strongly Presumed.  
No Change

| Extent of Damage | 1 |

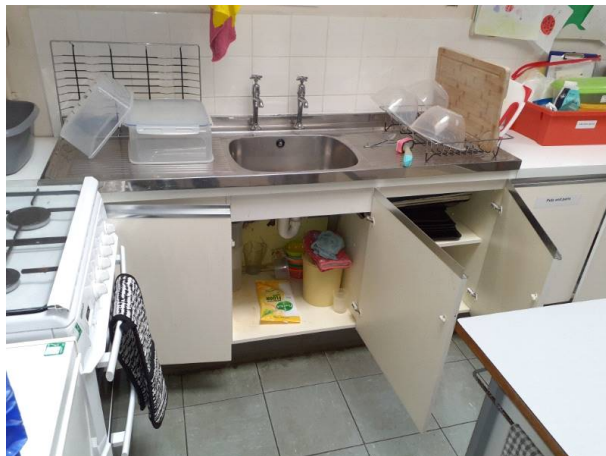
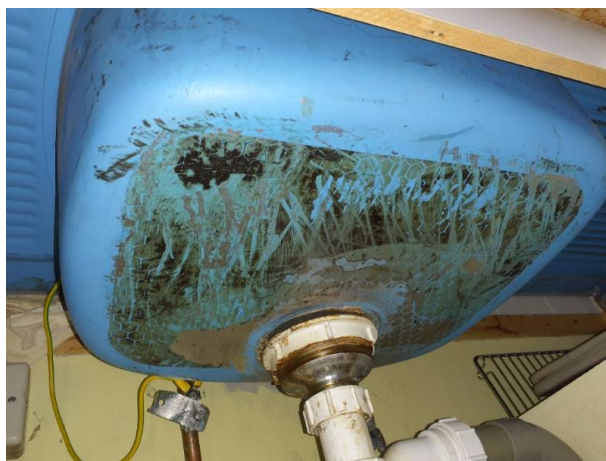
| Item Notes | Bitumen pads have been removed but residue remains. Encapsulate underside of sink and drainers<br>Updated |

| Extent of Damage | 2 |

| Repair and/or Encapsulate |

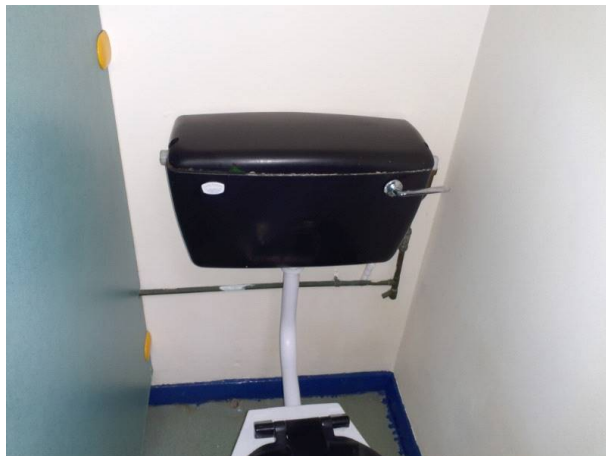
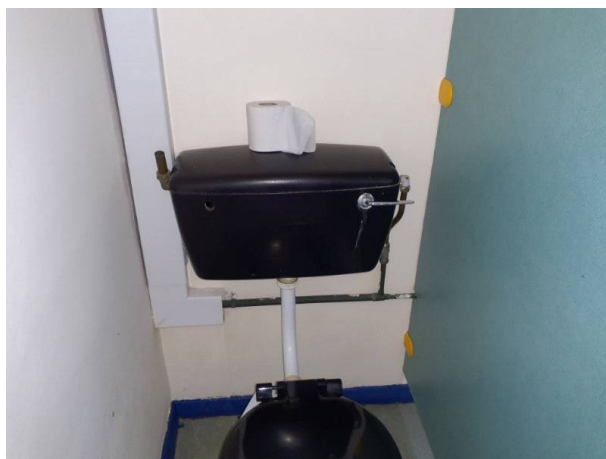
**Item Notes** No sample ref 13 - Strongly Presumed.  
No Change

| Extent of Damage | 1 |

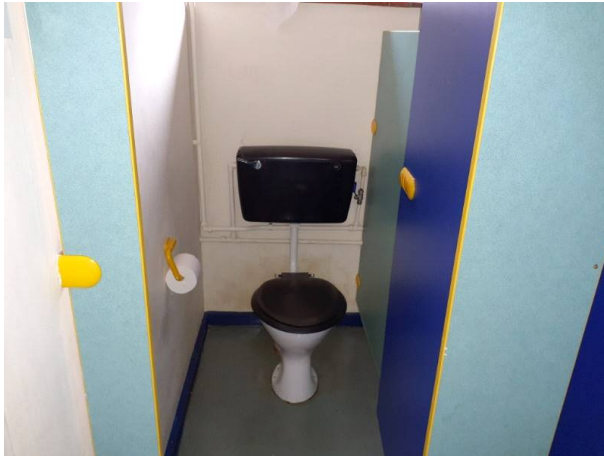
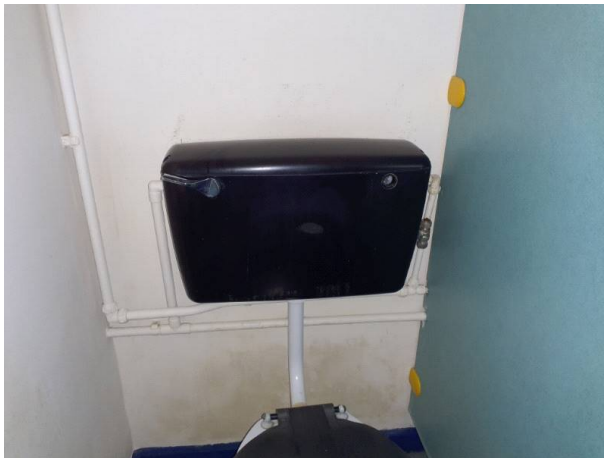
**Item Notes** No sample ref 17 - Strongly Presumed.  
No Change

| Extent of Damage | 1 |
