## P W INDUSTRIAL SERVICES LTD PCVR-KITCHEN VENTILATION

Nutfield Church C of E Primary School

| Conducted on | 04.04.2023 07:37 BST | | | | |

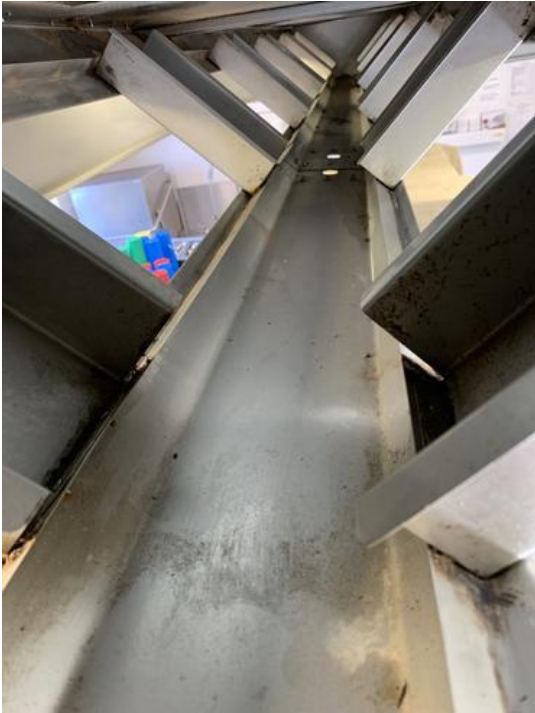
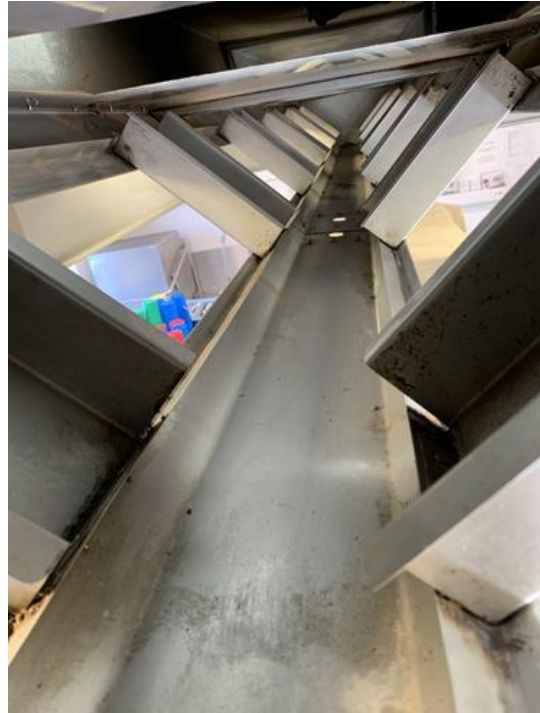
### 1) Canopy Extract Plenum

200

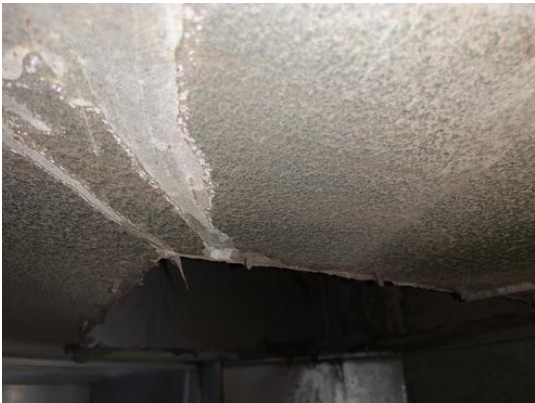
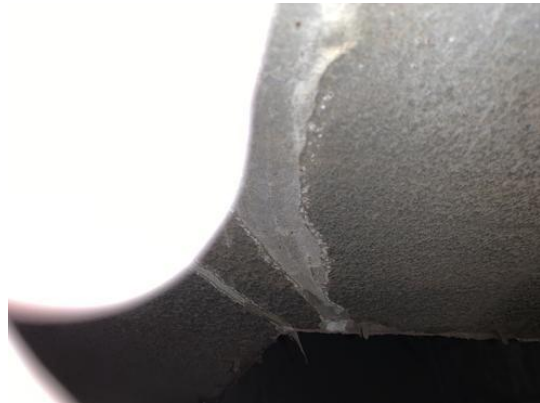
### 2) Duct 1 metres from Canopy

200

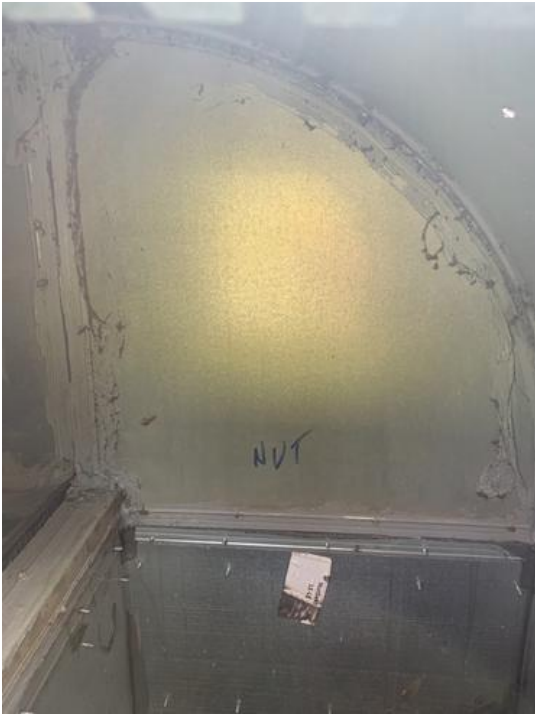
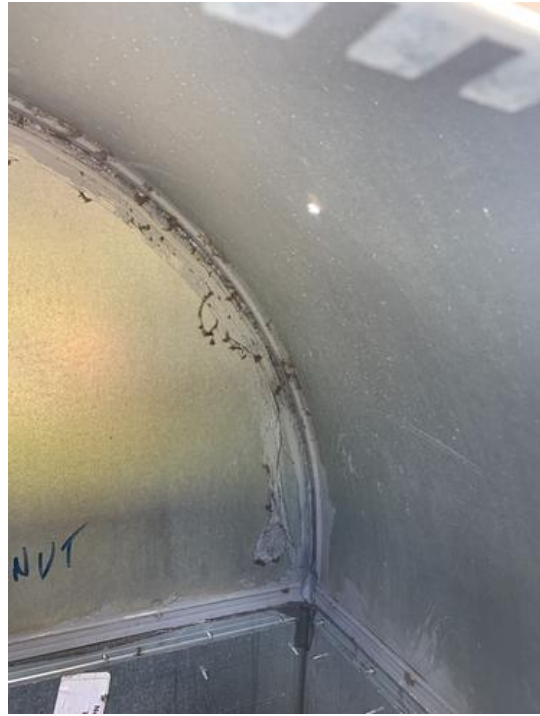
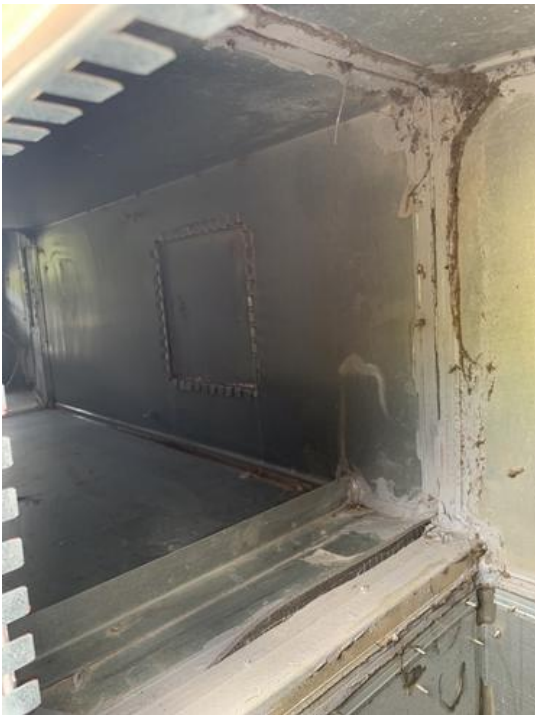
### 3) Duct 3 metres from Canopy

200

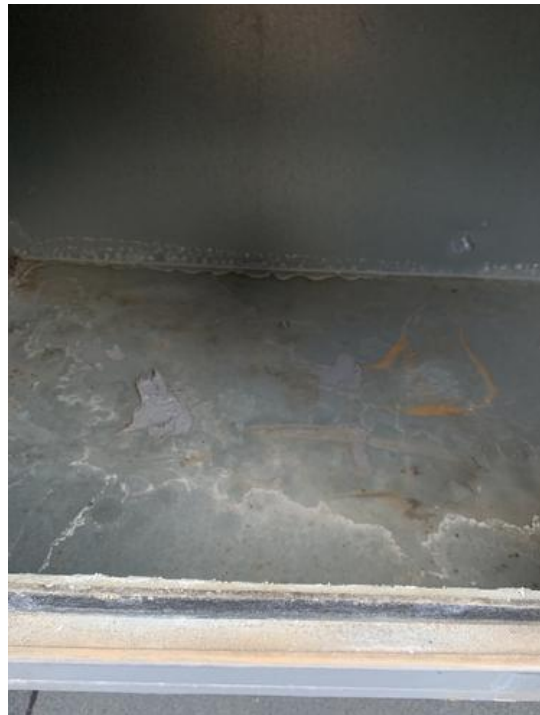
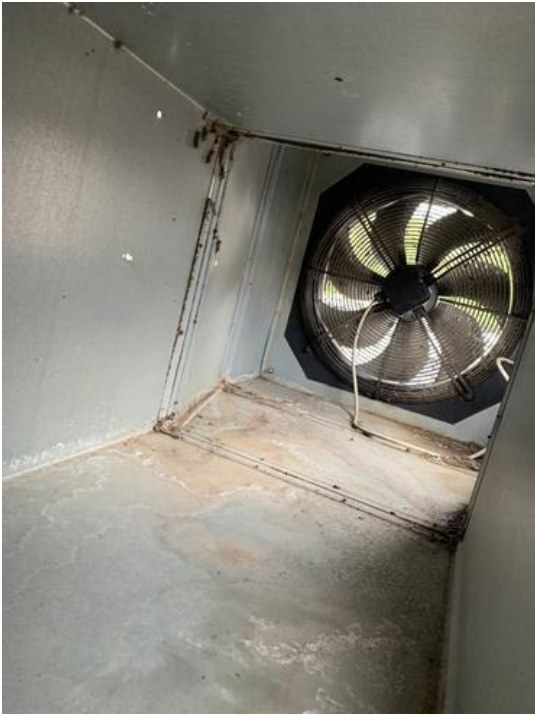
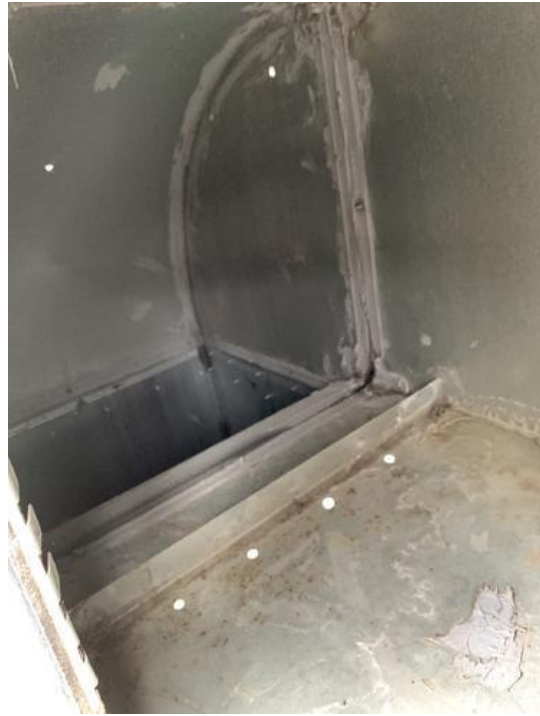
### 4) Duct midway between canopy and fan

200

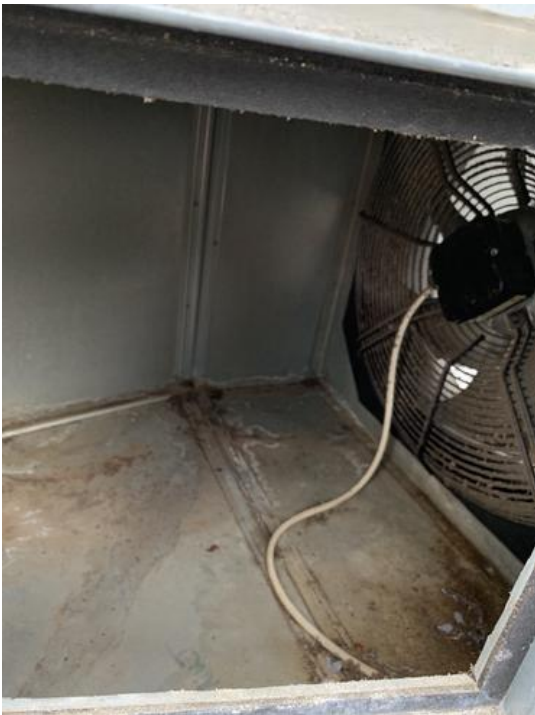
### 5) Duct upstream of fan

200

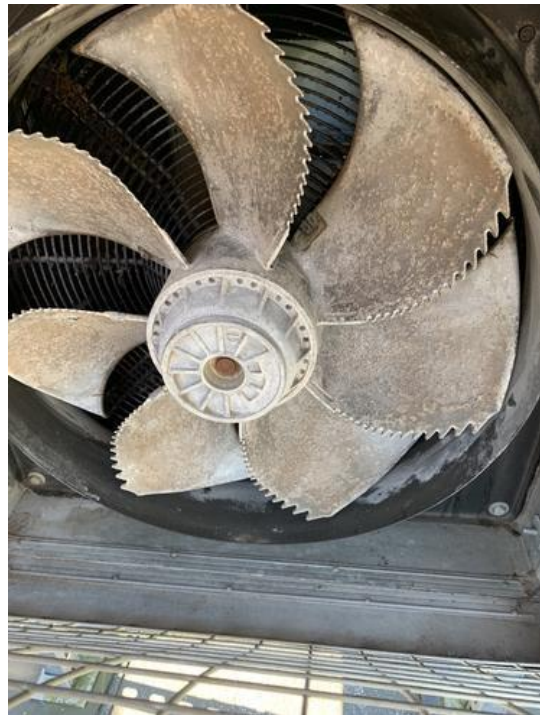
## 6) Extract Fan

200

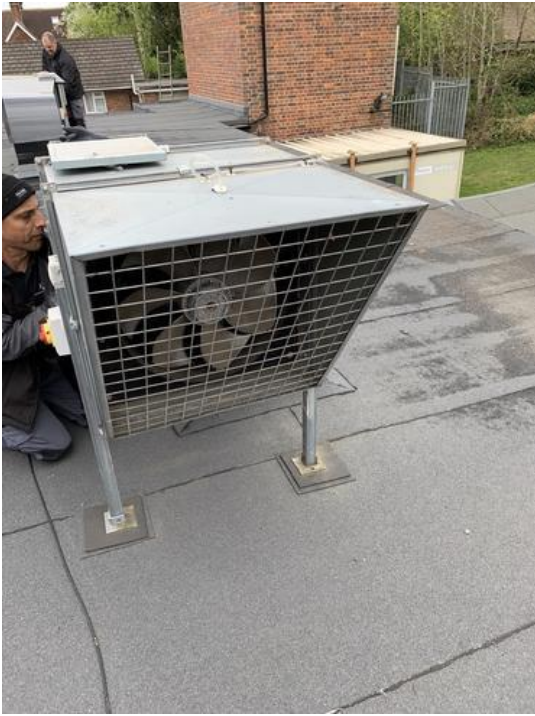
## 7) Discharge Duct from fan

200

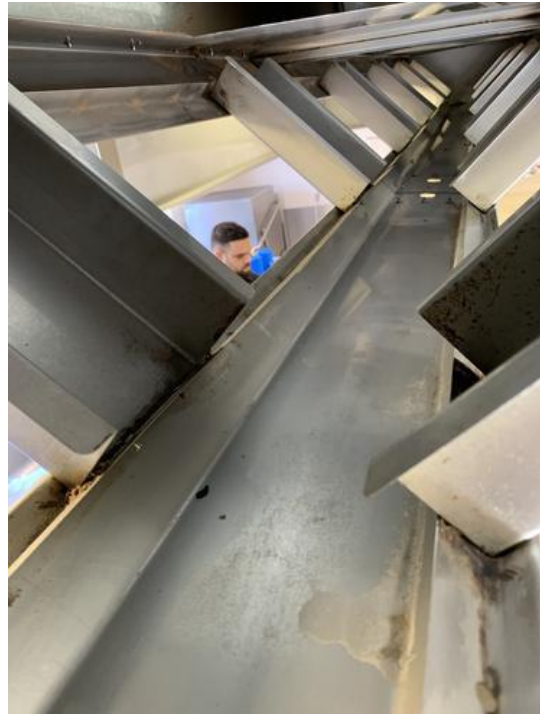
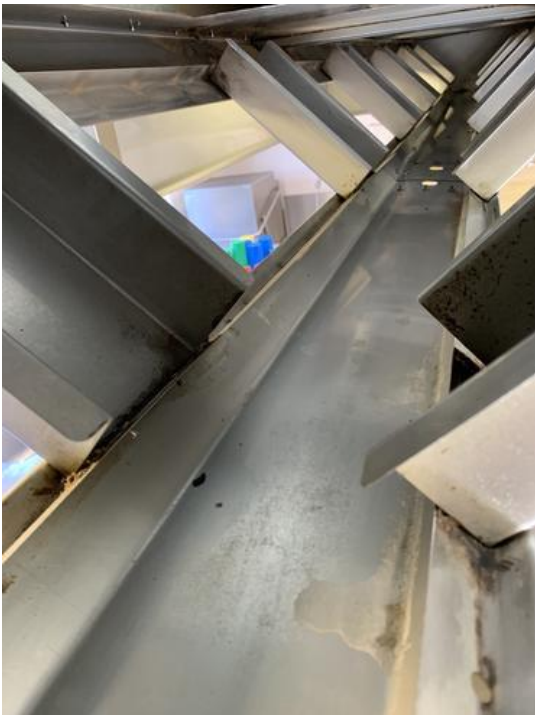
1) Canopy Extract Plenum

25

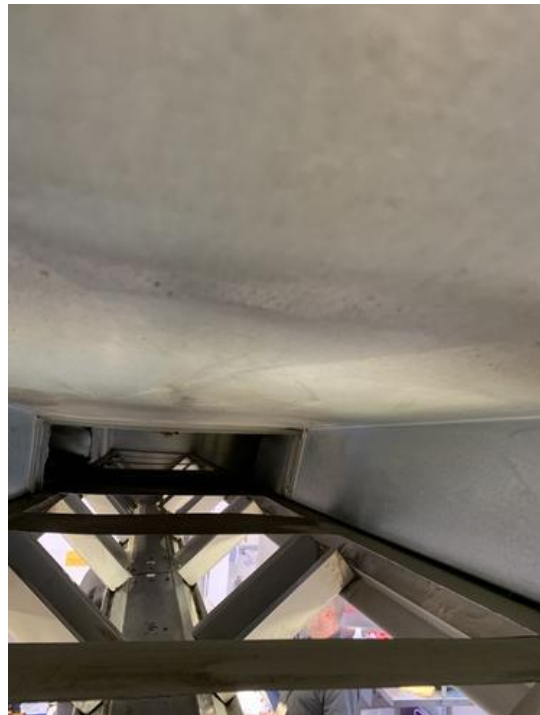
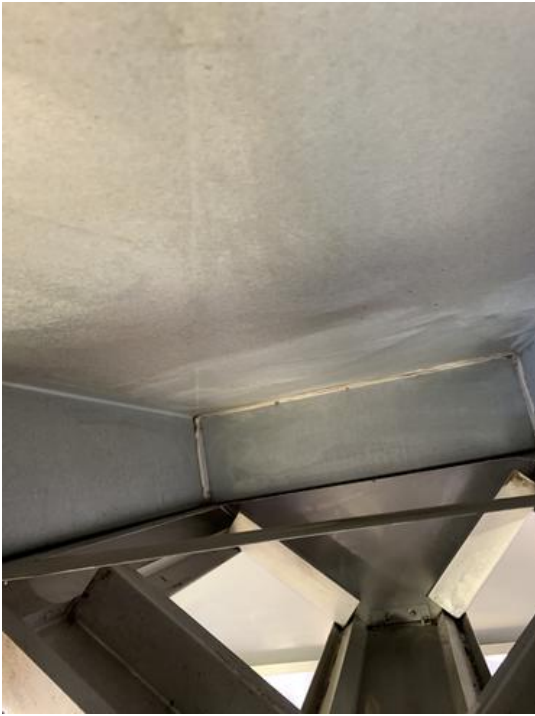
2) Duct 1 metres from Canopy

25

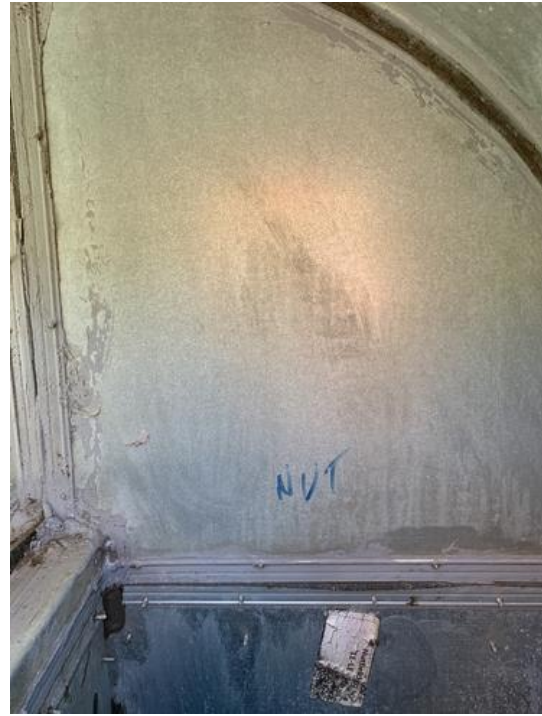
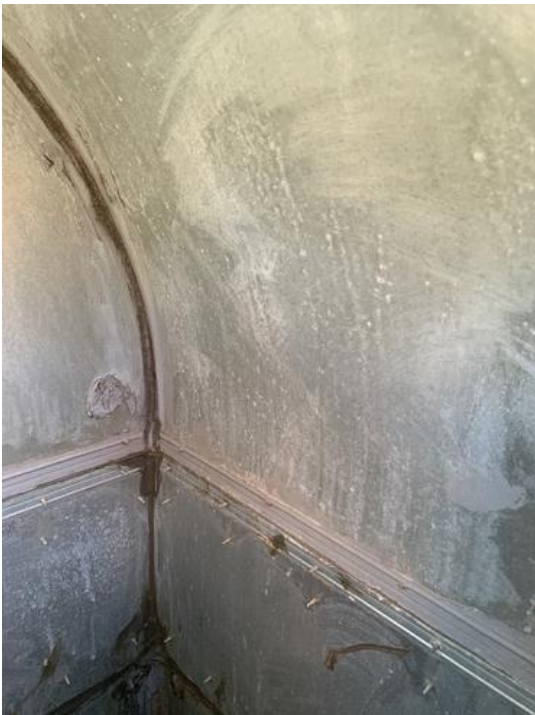
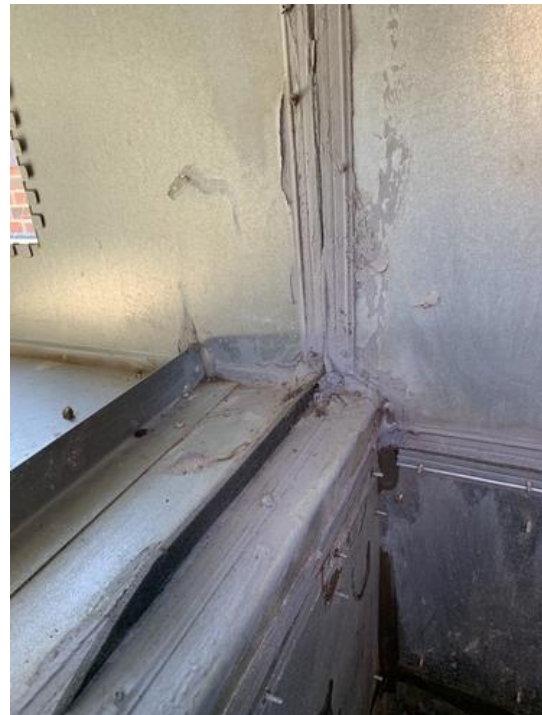
3) Duct 3 metres from Canopy

25

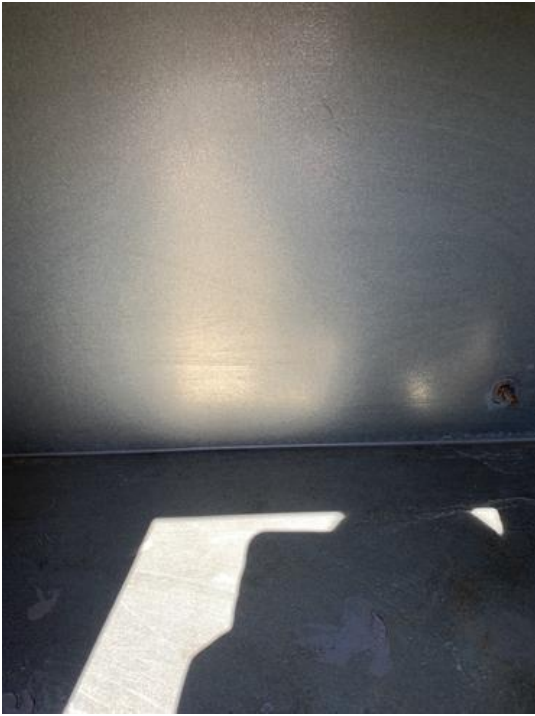
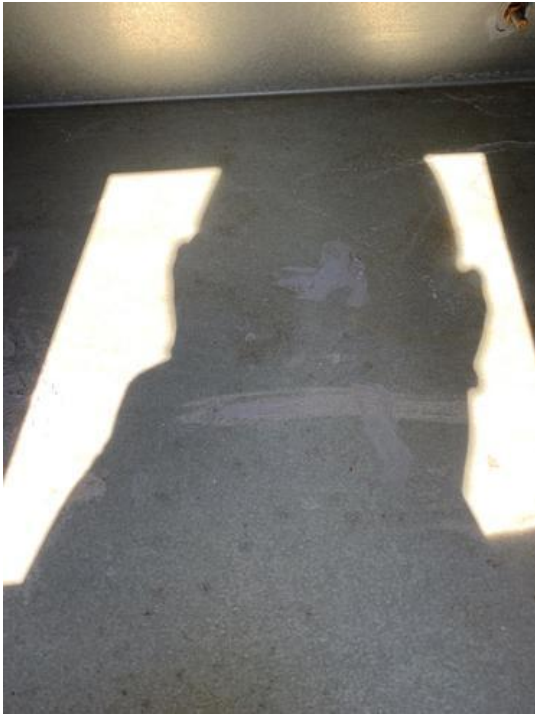
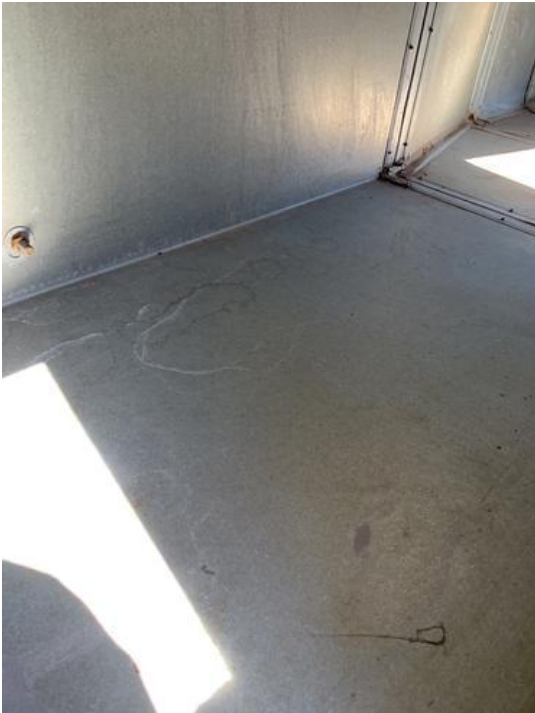
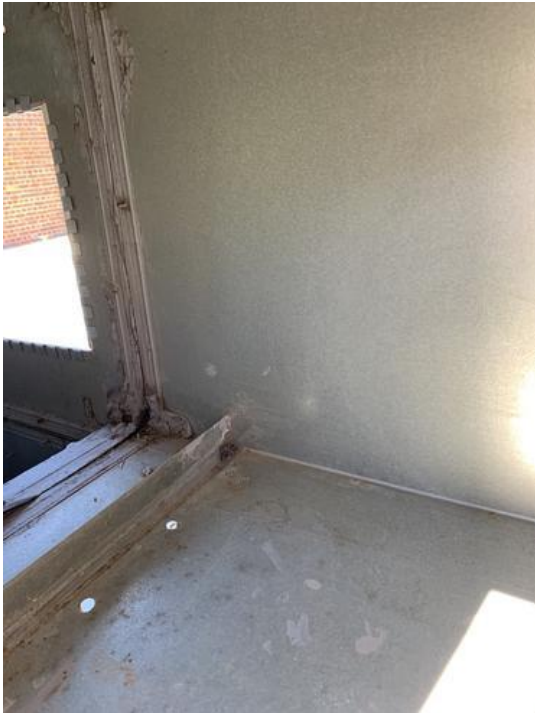
4) Duct midway between canopy and fan

25

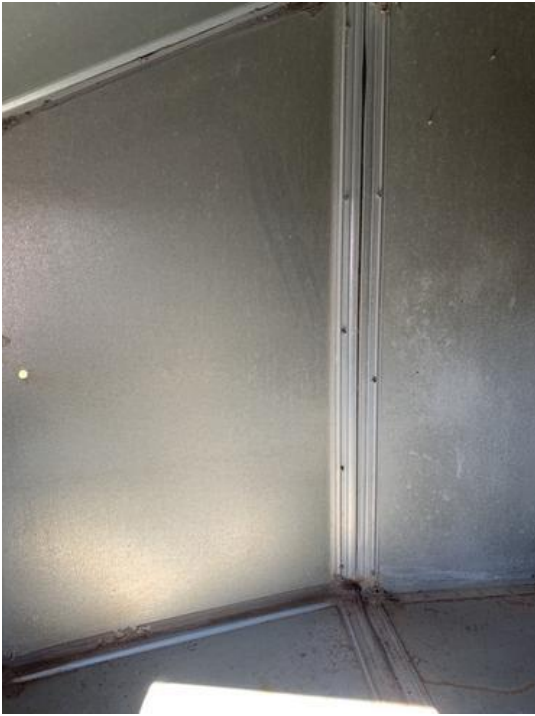
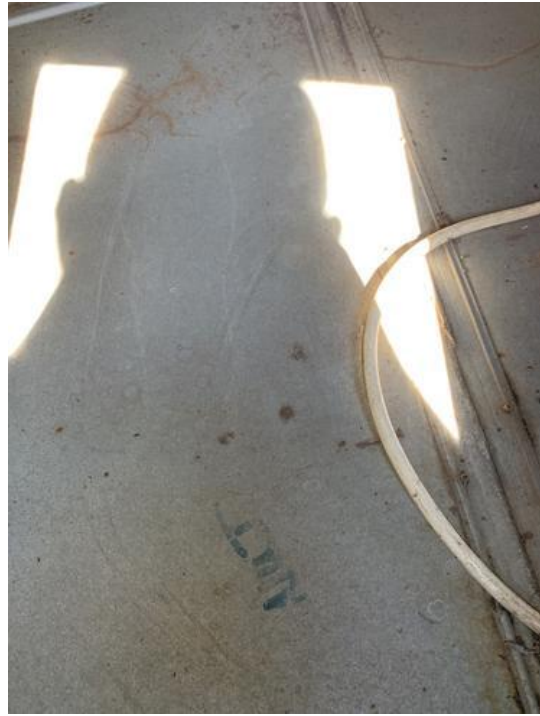
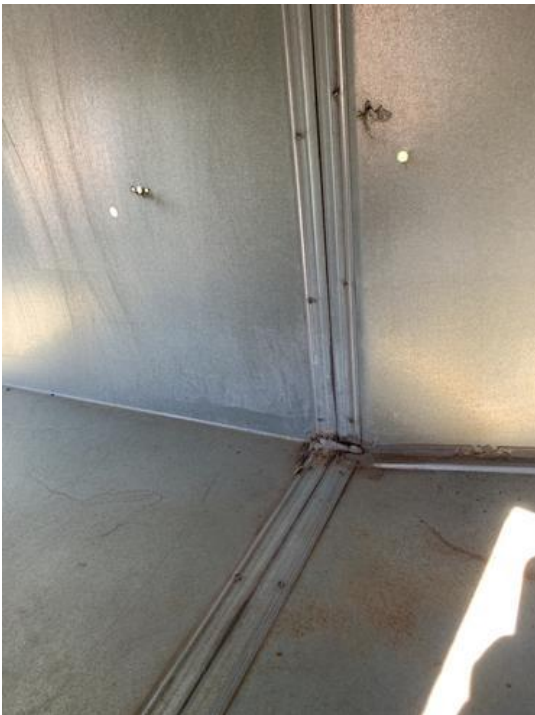
5) Duct upstream of fan

25

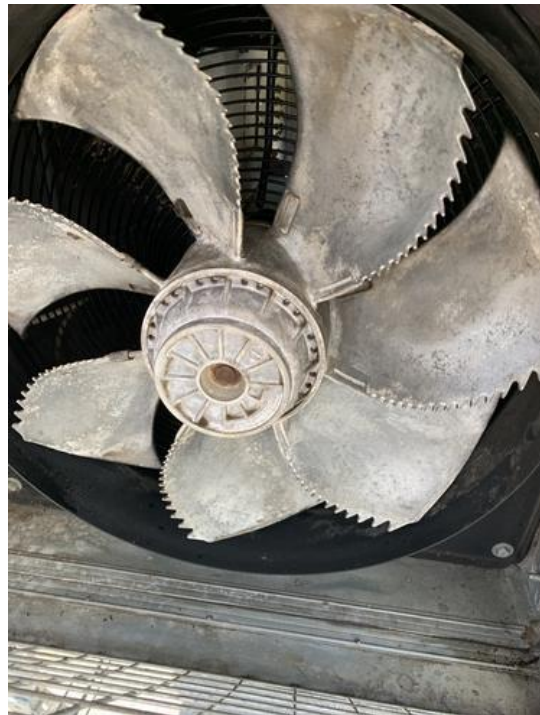
## 6) Extract Fan

25

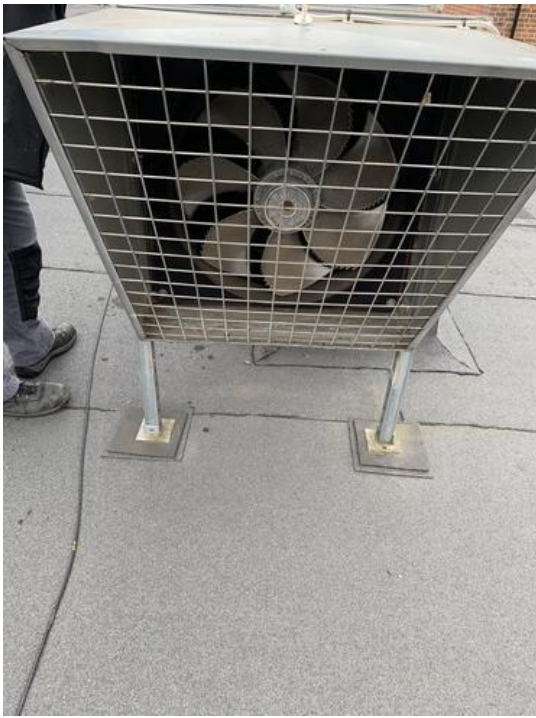
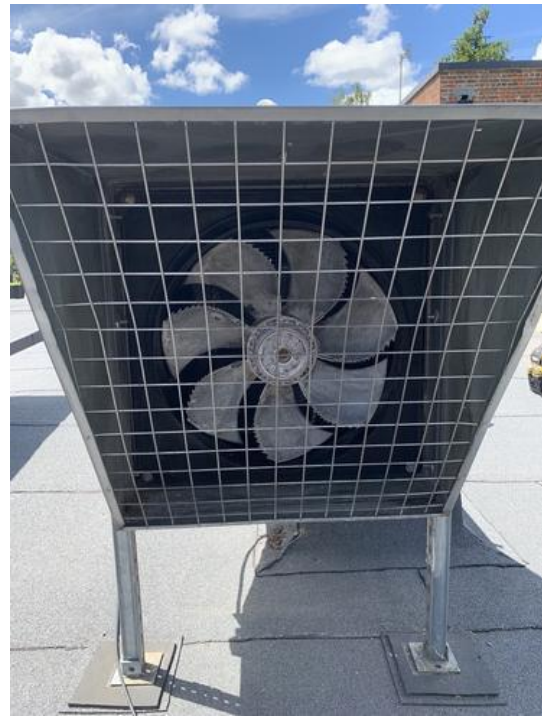
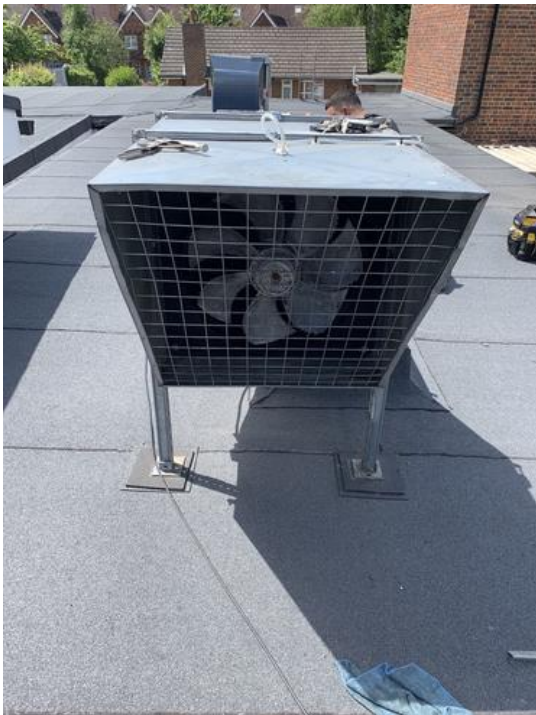
## 7) Discharge Duct from fan

25

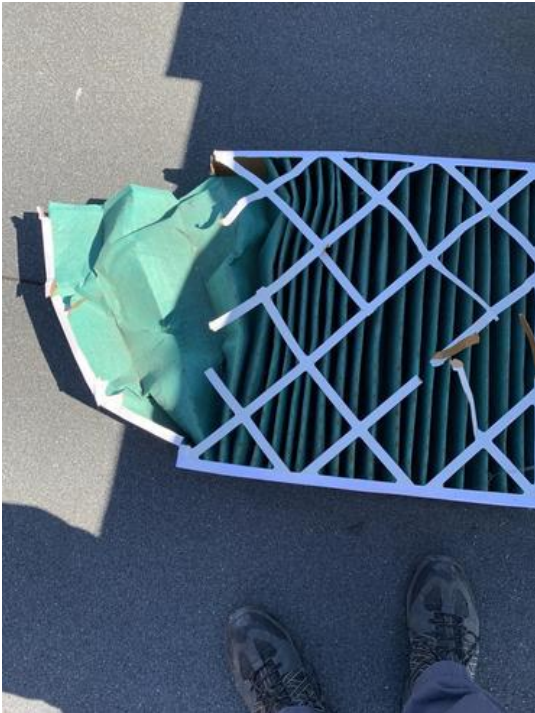
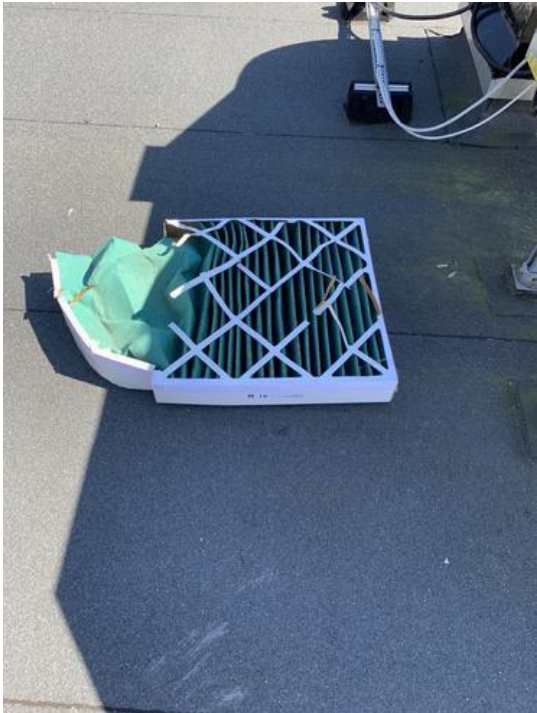
**Photo of Air filters**

Pleated panel

H 594 x W 594 x d 95

New supply filter needed
