# Condition Data Collection 2 School Condition Report

Nutfield Church CofE Primary School

| <b>Surveyor Visit Date:</b> | 03 February 2023 |

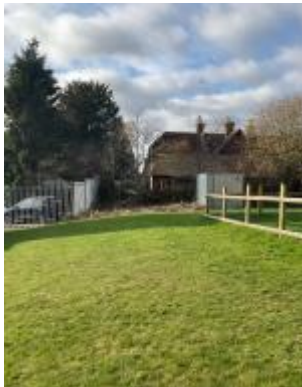
| <p>33520 Nutfield Church CofE Primary School (CDC2) / EFA1 / 11.03.02 / 1</p> | <b>Photo Reference</b> | EFA1/11.03.02 |

| | <b>Element/Sub Element</b> | 11. Site Areas & External Areas / 11.03. Boundary Walls and Fences / |
| | <b>Construction Type</b> | Timber / Metal / Chain Link |
| | <b>Condition Grade C%</b> | 5 |

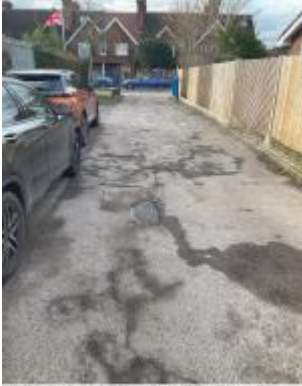
| <p>135/00 Nutfield Church CofE Primary School (DDC2) / EFA1 / 11.05.01 / 1</p> | <b>Photo Reference</b> | EFA1/11.05.01 |

| | <b>Element/Sub Element</b> | 11. Site Areas & External Areas / 11.05. Ground Surface / |
| | <b>Construction Type</b> | Tarmac / Concrete Roads, Vehicle Hardstandings and Car Parks |
| | <b>Condition Grade C%</b> | 100 |

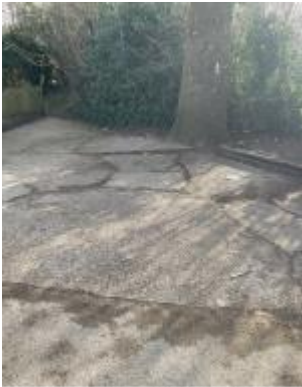
| <p>135/00 Nutfield Church CofE Primary School (DDC2) / EFA1 / 11.05.03 / 1</p> | <b>Photo Reference</b> | EFA1/11.05.03 |

| | <b>Element/Sub Element</b> | 11. Site Areas & External Areas / 11.05. Ground Surface / |
| | <b>Construction Type</b> | Tarmac / Concrete Paths and Non Vehicle Hardstanding Areas |
| | <b>Condition Grade C%</b> | 10 |

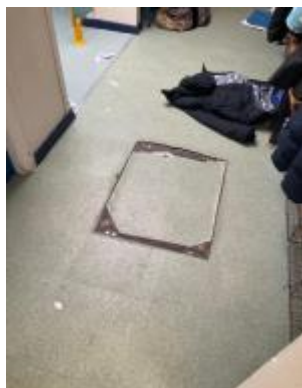
325/00 Nutfield Church CofE Primary School (DDC2) / EFAA / 02.03.03 / 1

| <b>Element/Sub Element</b> | 02. Floors and Stairs / 02.03. Floor Applied Finish / |
| <b>Construction Type</b> | Vinyl / Rubber / Cork in Tiles / Sheet |
| <b>Condition Grade C%</b> | 10 |

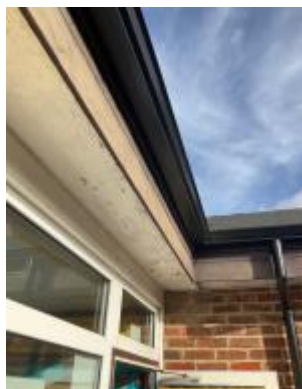
325/00 Nutfield Church CofE Primary School (DDC2) / EFAA / 09.02.02 / 1

| <b>Element/Sub Element</b> | 09. Redecorations / 09.02. External - Windows Doors and External Joinery / |
| <b>Construction Type</b> | Painted |
| <b>Condition Grade C%</b> | 80 |
