# Asbestos Reinspection Survey Report

## Nutfield Church Primary School 59 Midstreet South Nutfield

J062167 784-B038407  
6 Sep 2022

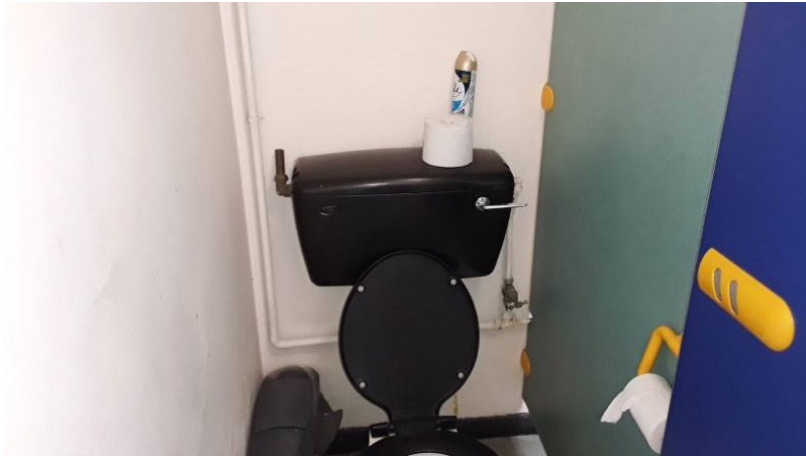
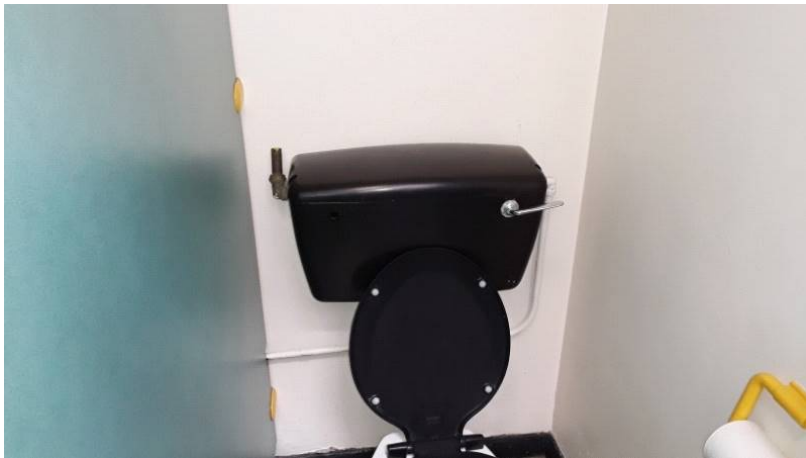
**Item Notes** No sample ref 6 - Strongly Presumed.  
No Change

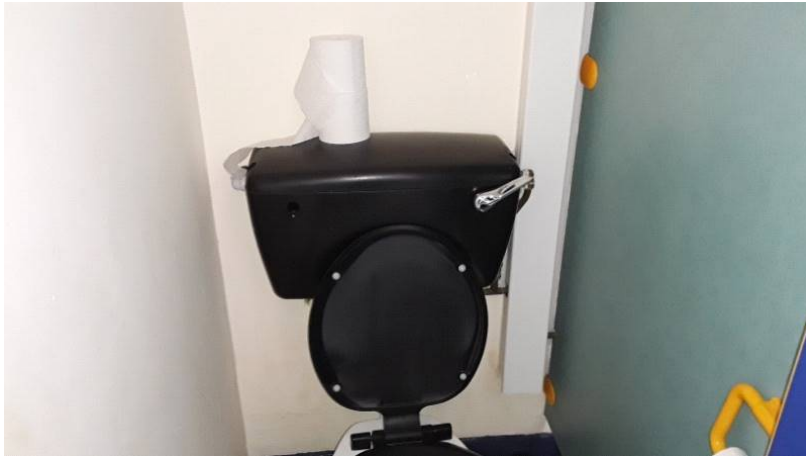
| Item Notes | No Change |

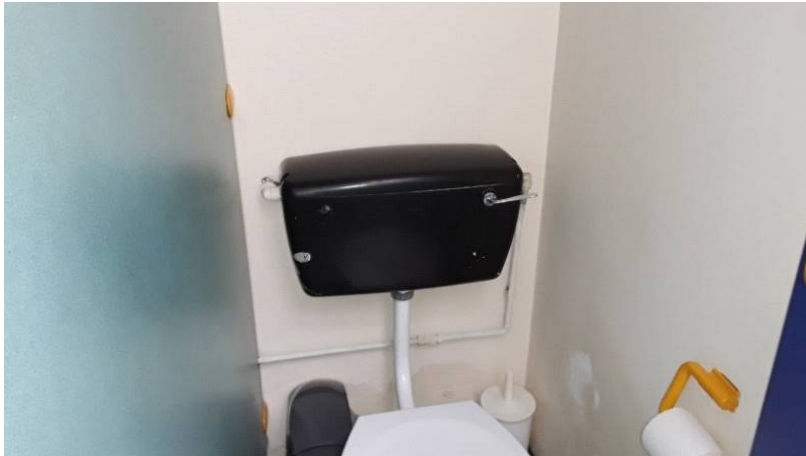
**Item Notes** No sample ref 2 - Strongly Presumed.  
No Change

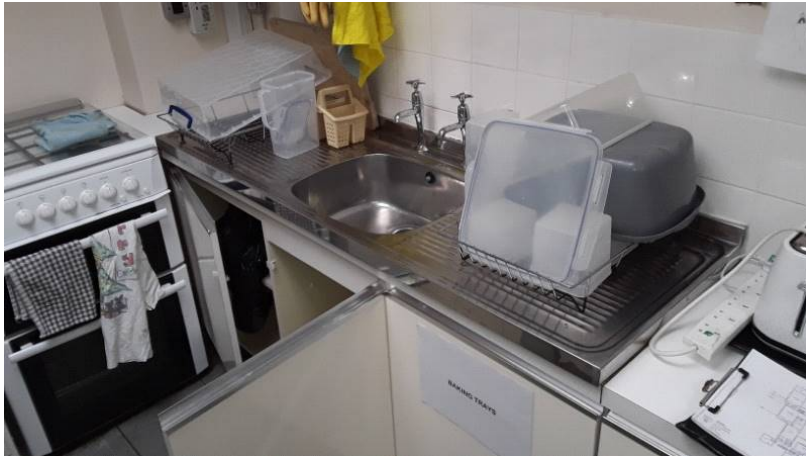
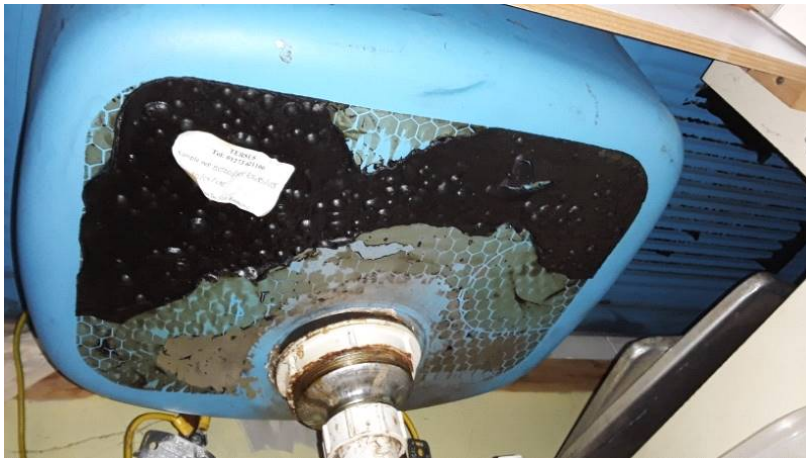
| Area | Inspection Number | Feature | Extent | Material Type – (Friability) | Asbestos Fibre | Material Assessment Score | Priority Assessment Score | Risk Assessment Score | Sample Number | Recommendations |
|---|---|---|---|---|---|---|---|---|---|---|
| Main Building, Ground Floor, Food Tech (064) | 4 | Acoustic pad to sink | 3 no. | Well Bound Material (Low) | (1) Chrysotile | 5 (Low) | 6 | 11 (Band C) | B/SU14/8/008 {CP000601}* | Repair or Remove |

| Item Notes | Sections starting to peel off. Monitor for further deterioration. Loose section beneath drainer and pieces fallen off. Remove acoustic pads<br>Damaged |

Repair or Remove

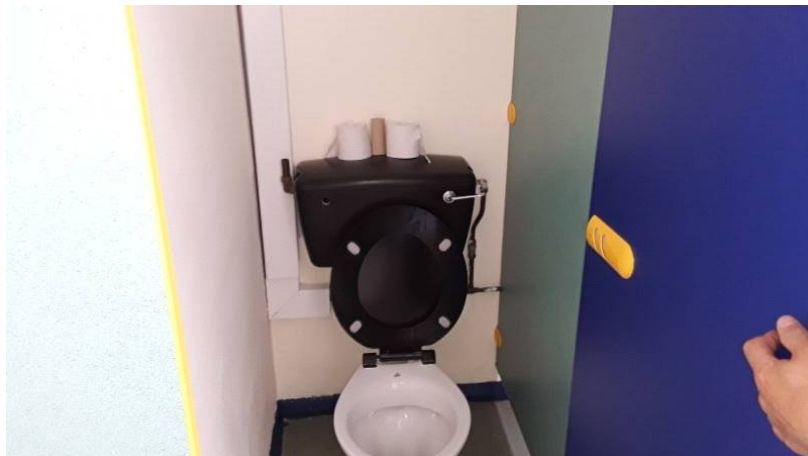
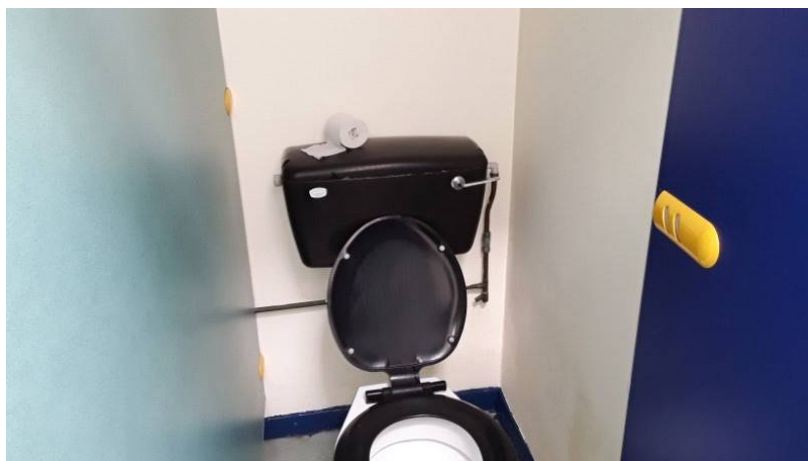
**Item Notes** No sample ref 13 - Strongly Presumed.  
No Change

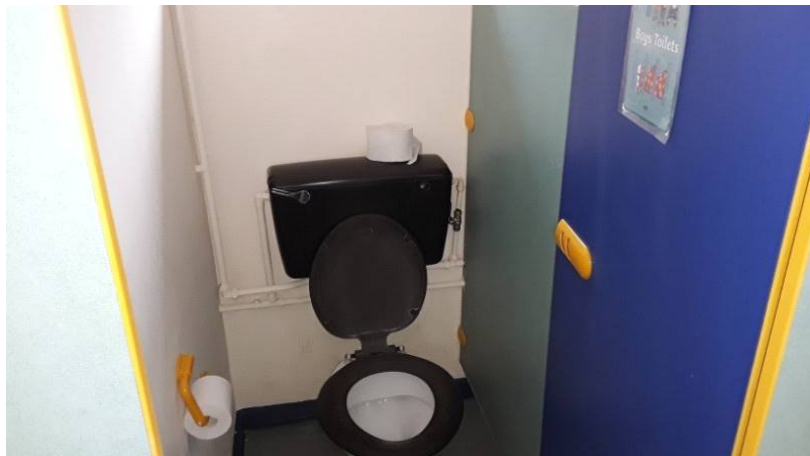
**Item Notes** No sample ref 17 - Strongly Presumed.  
No Change
