## P W INDUSTRIAL SERVICES LTD PCVR-KITCHEN VENTILATION

Nutfield Church C of E Primary School

## Summary- TR19

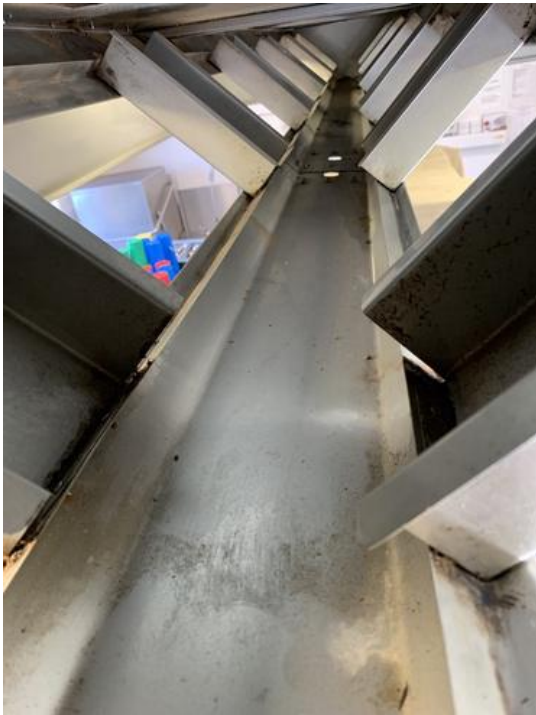
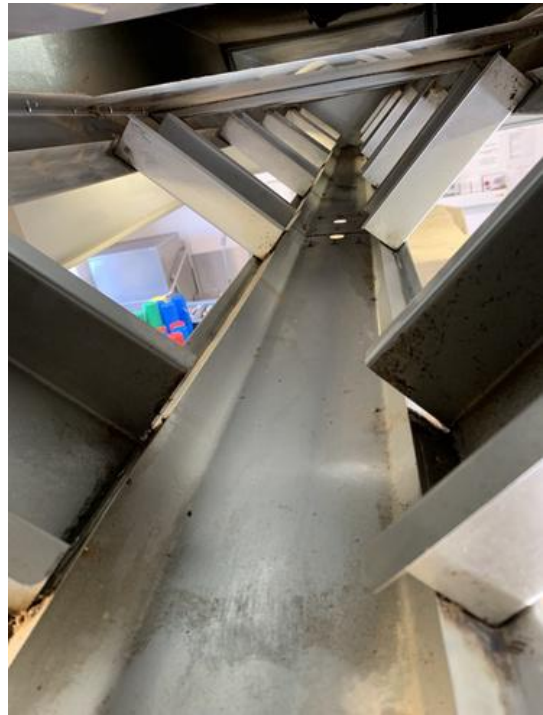
Photo 1

1) Canopy Extract Plenum

200

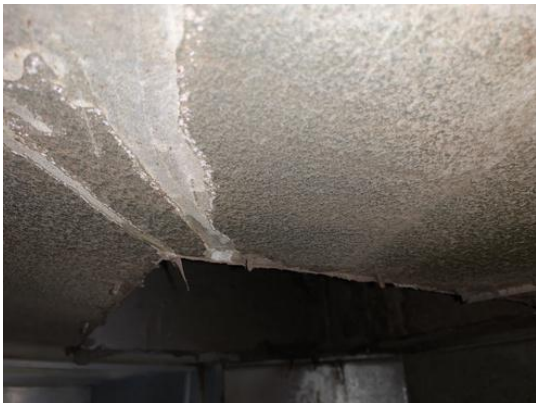
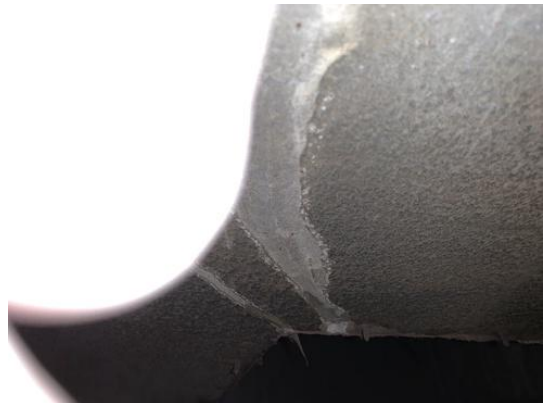
Photo 3

2) Duct 1 metres from Canopy

200

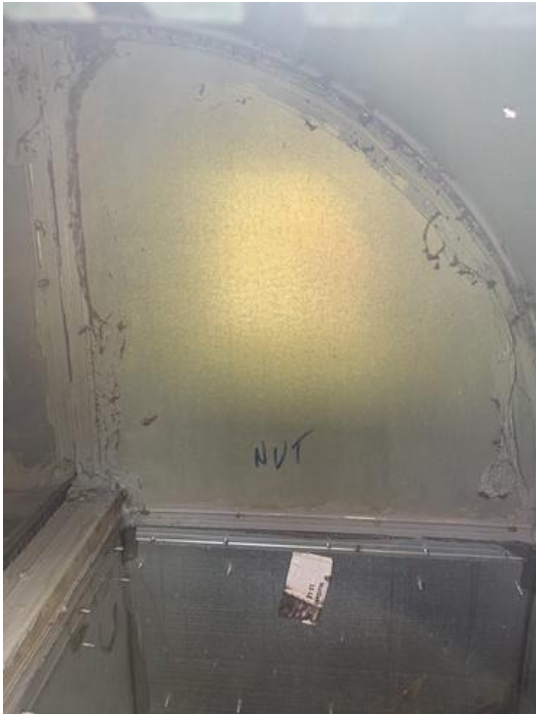
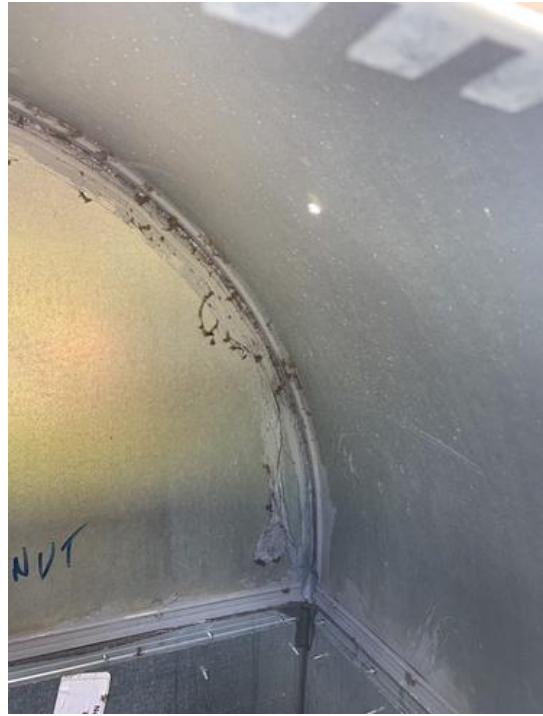
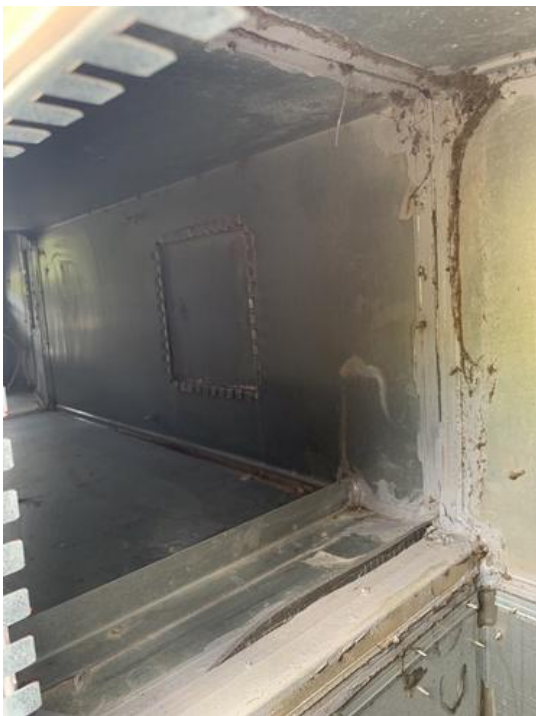
3) Duct 3 metres from Canopy

200

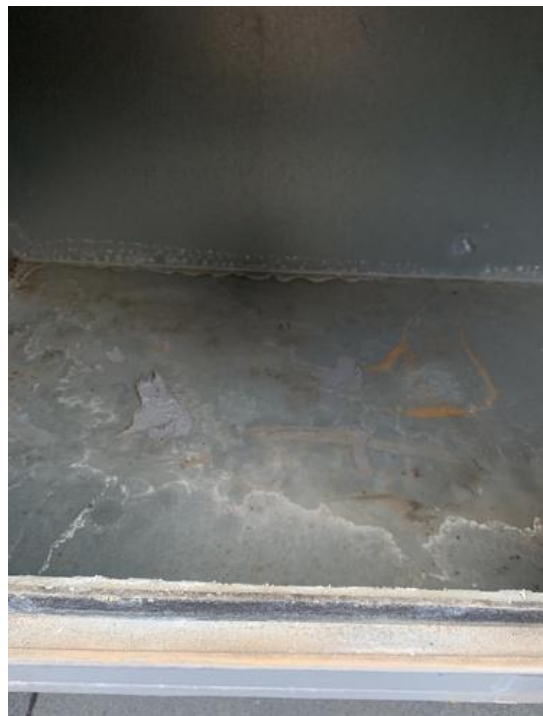
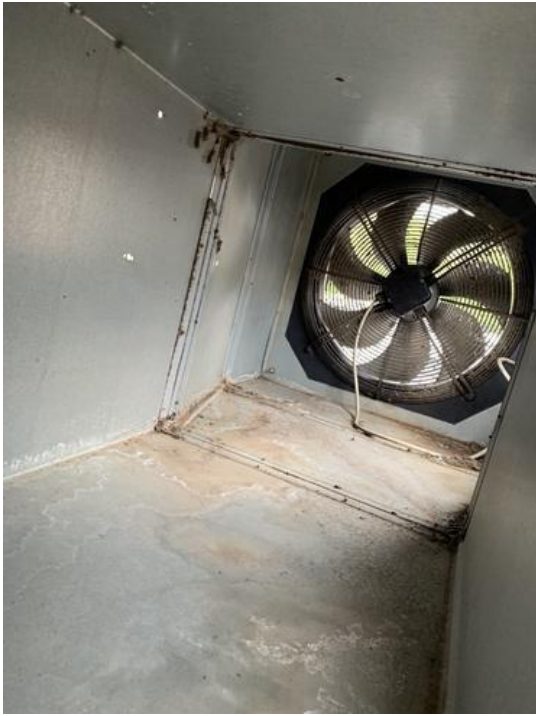
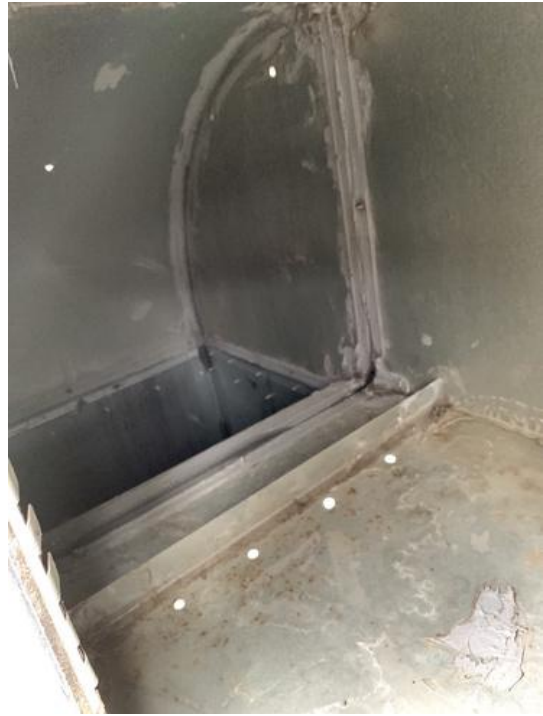
4) Duct midway between canopy and fan

200

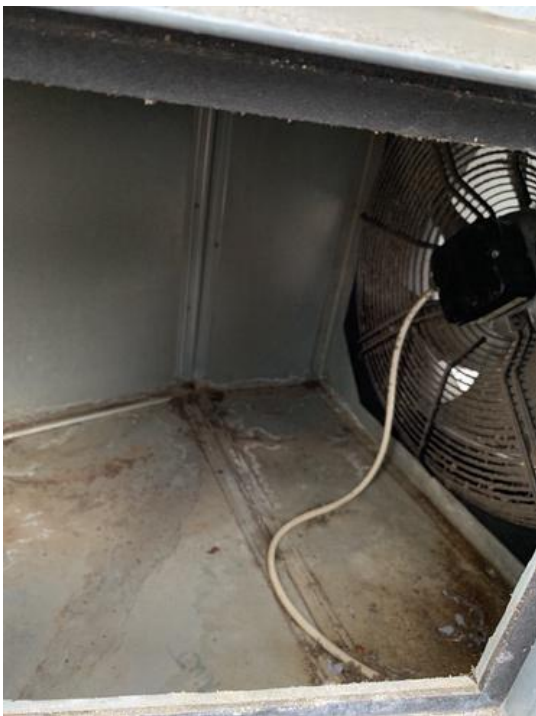
Photo 11

5) Duct upstream of fan

200

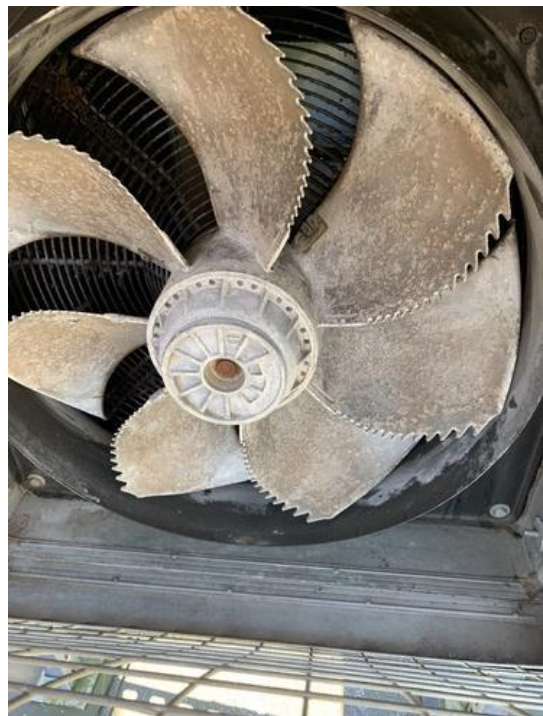
Photo 12

## 6) Extract Fan

200

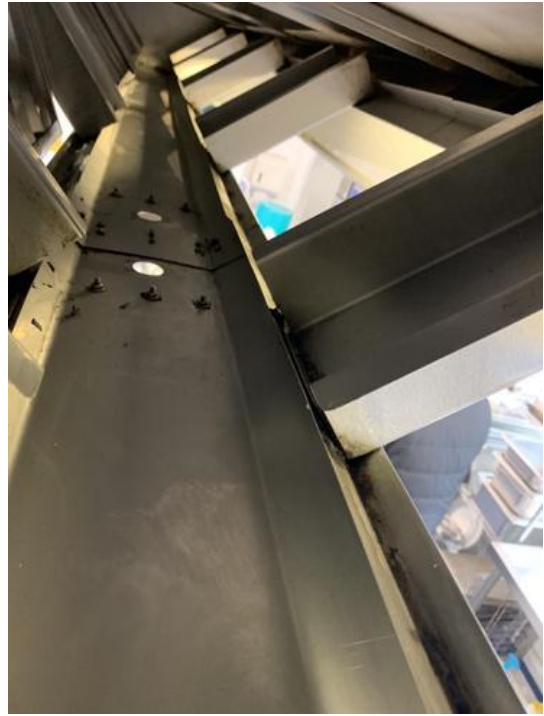
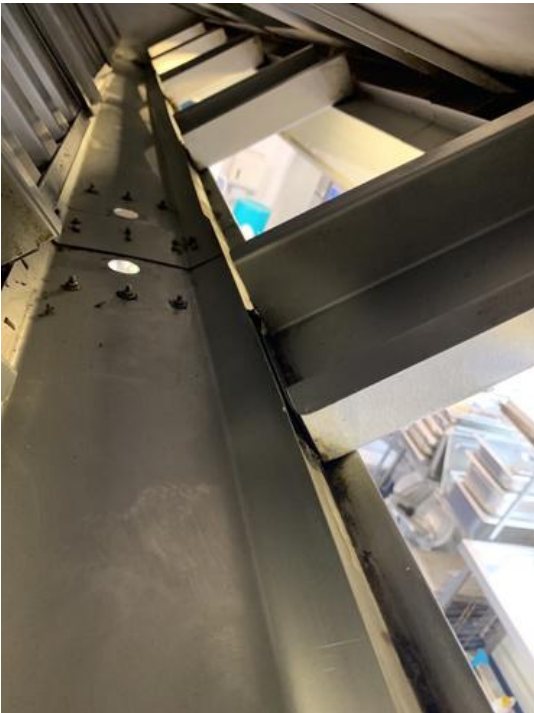
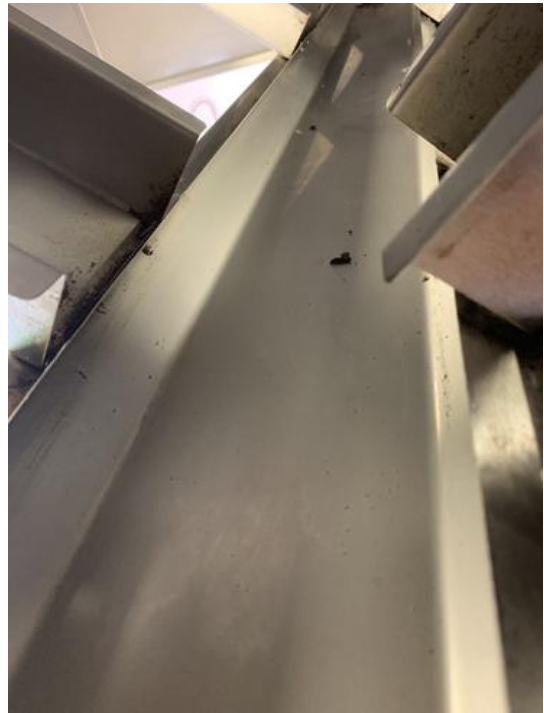
1) Canopy Extract Plenum

25

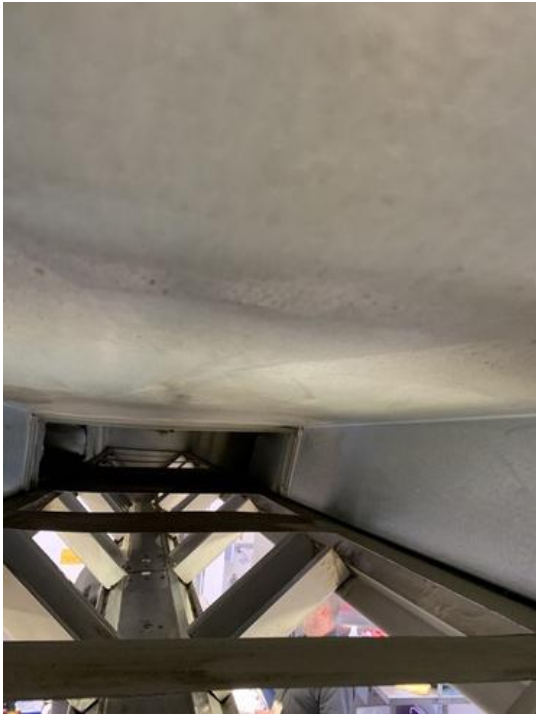
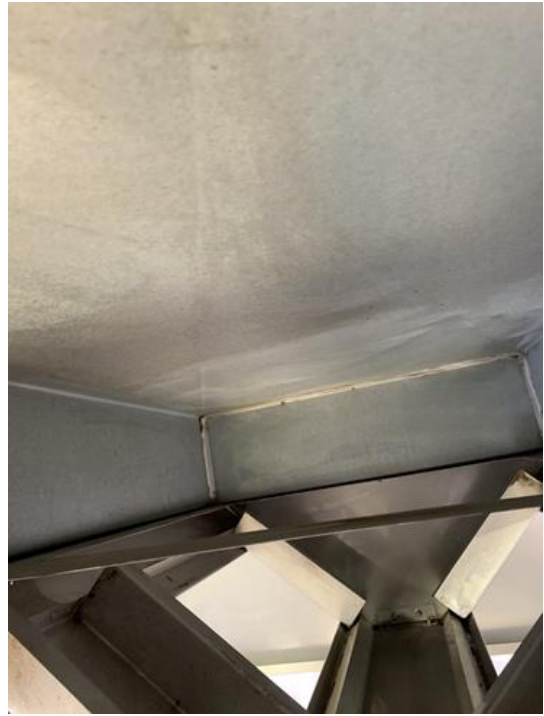
2) Duct 1 metres from Canopy

25

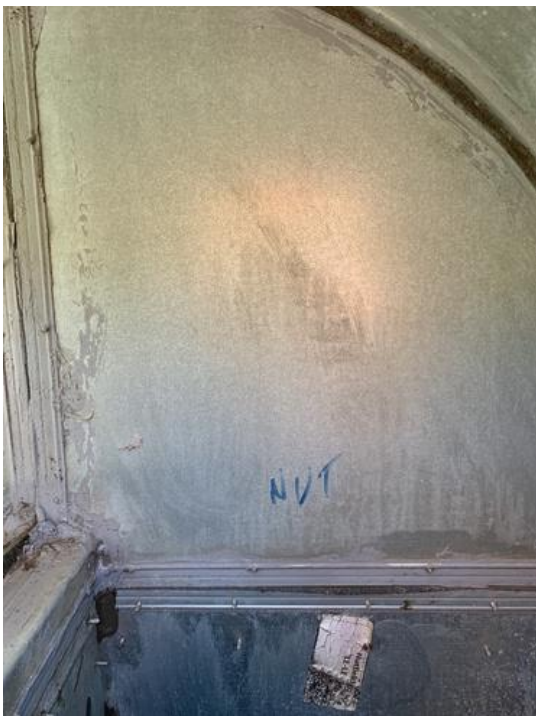
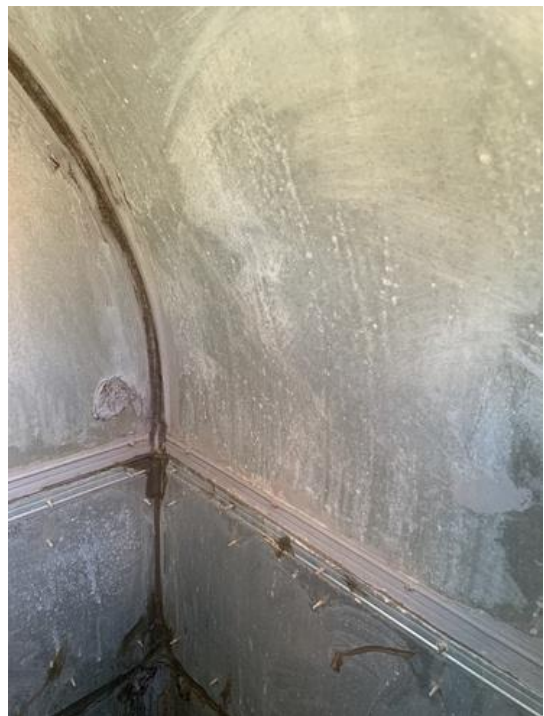
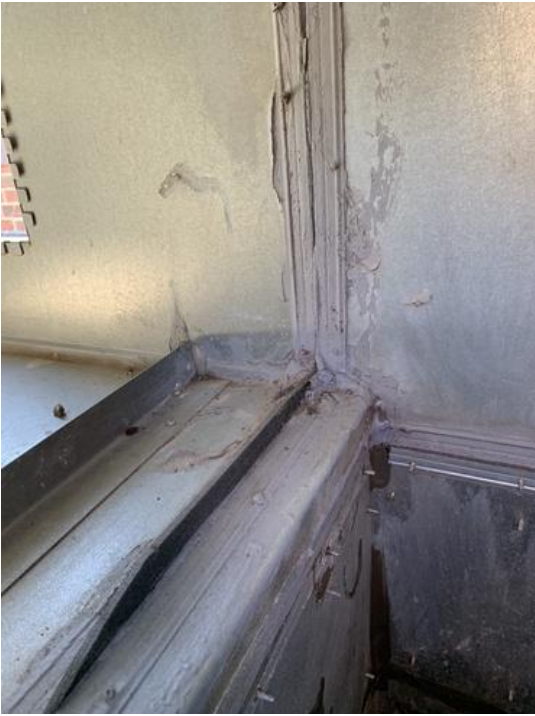
3) Duct 3 metres from Canopy

25

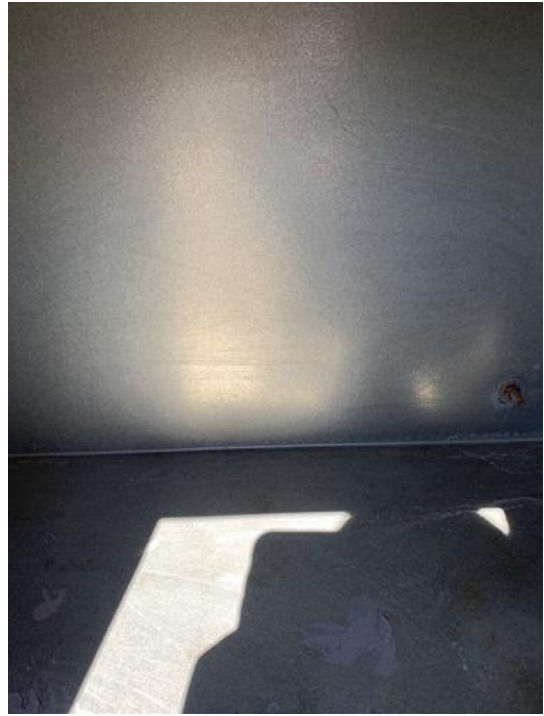
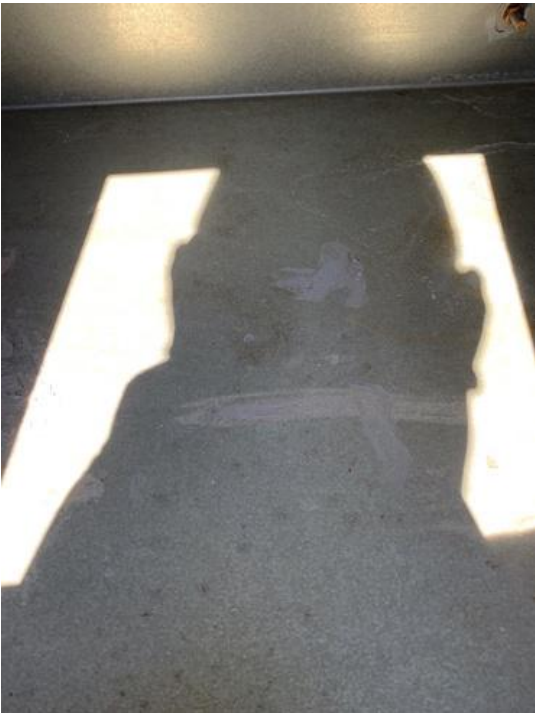
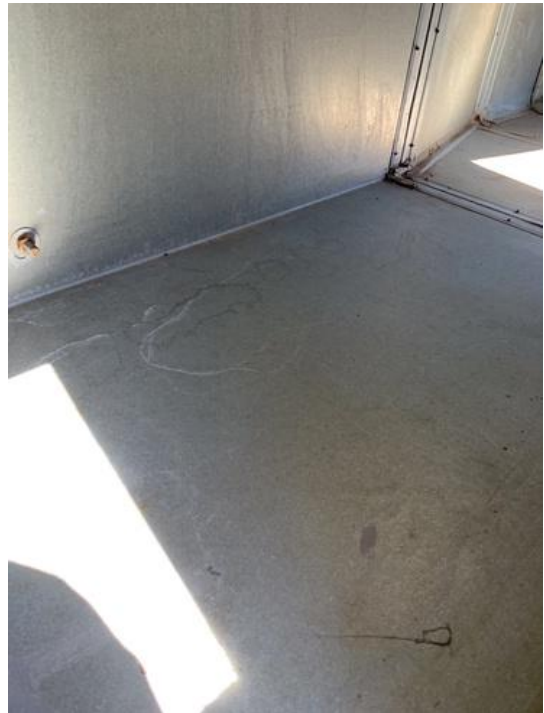
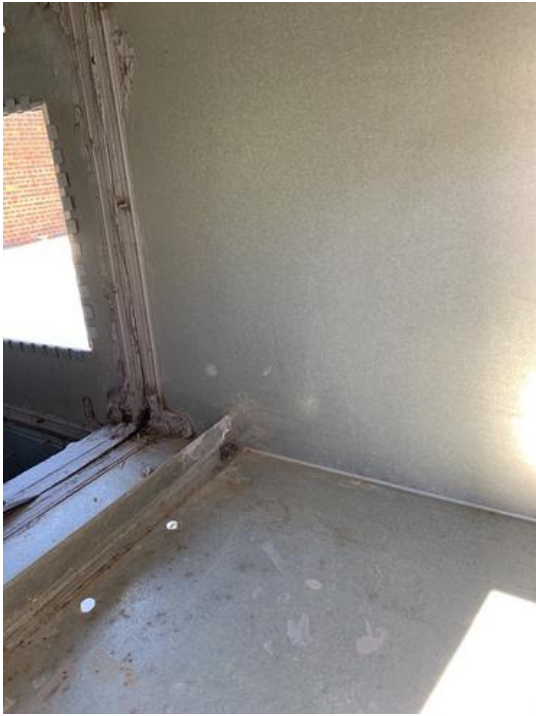
4) Duct midway between canopy and fan

25

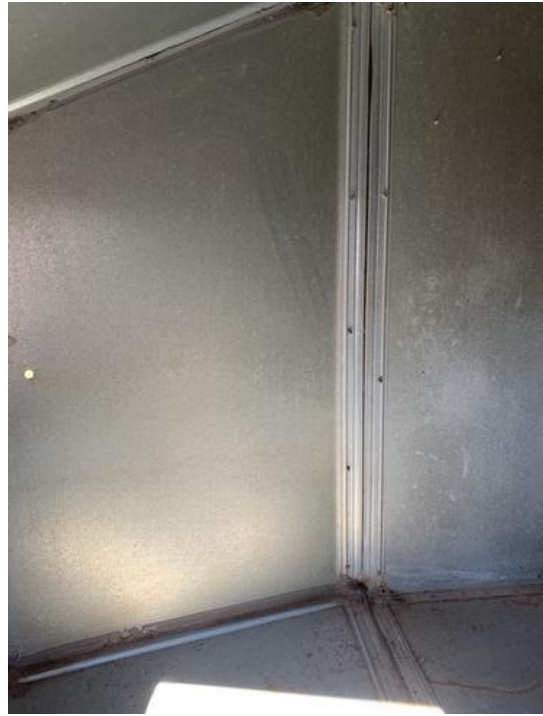
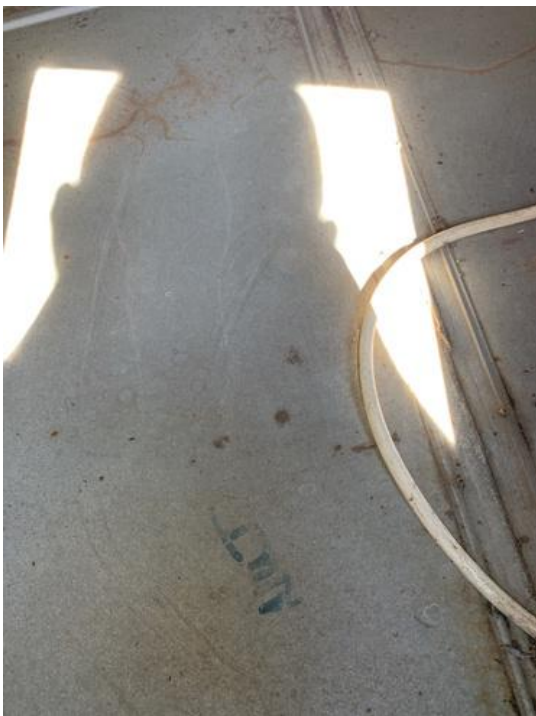
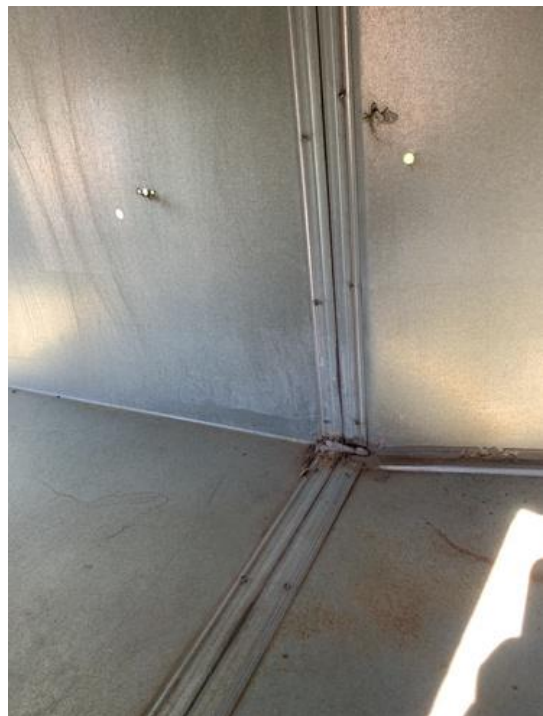
5) Duct upstream of fan

25

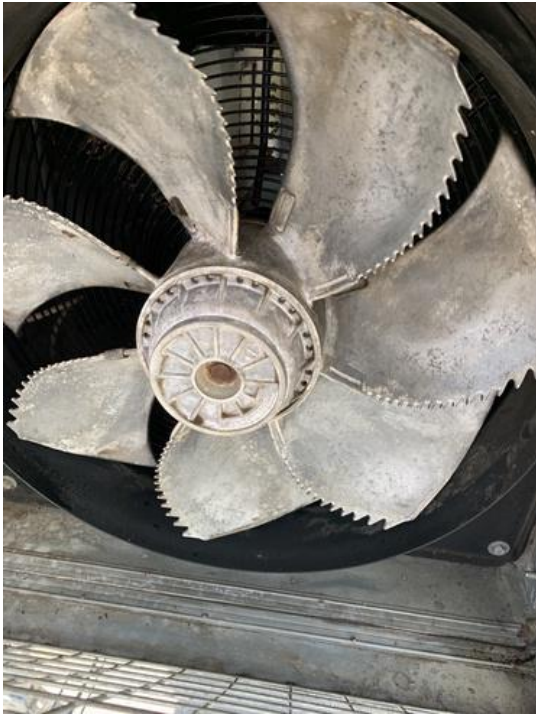
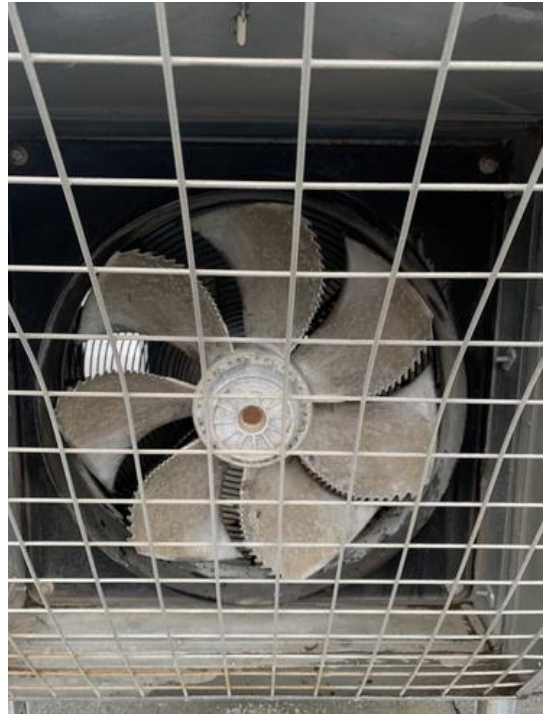
## 6) Extract Fan

25

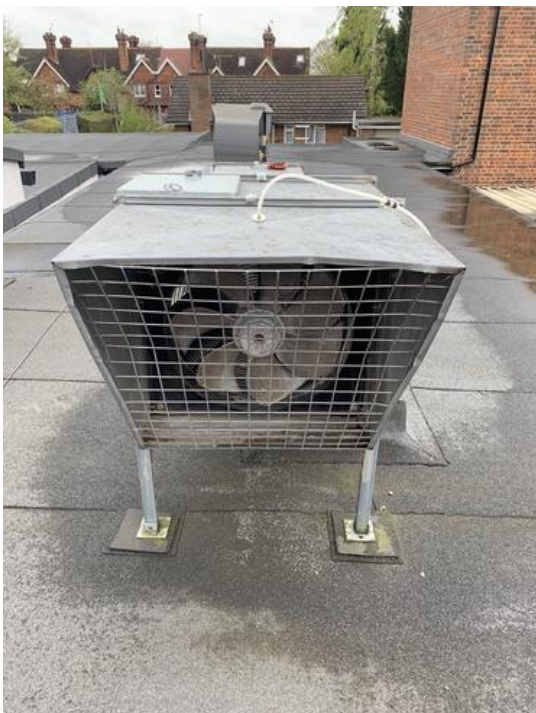
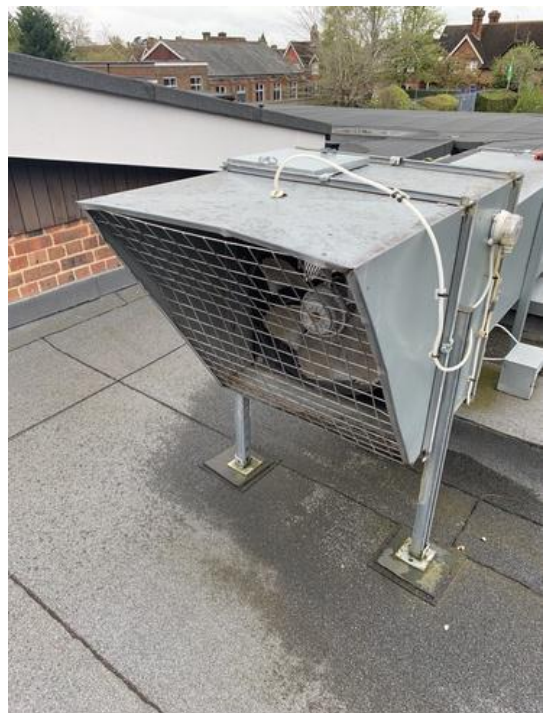
## 7) Discharge Duct from fan

25

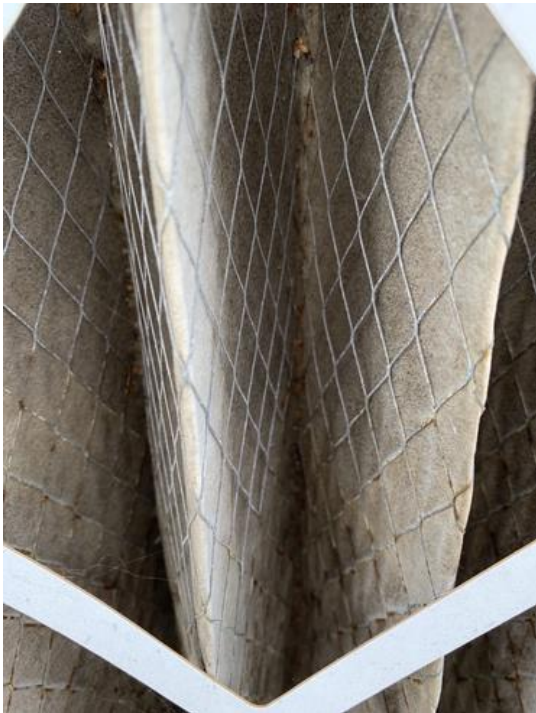
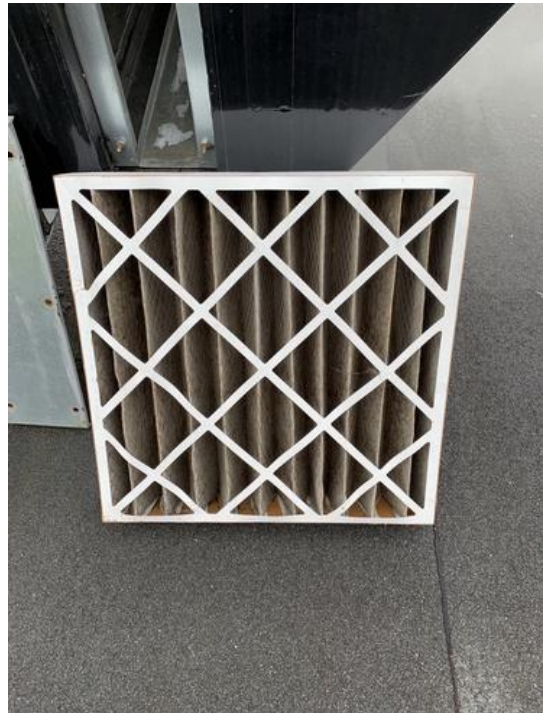
| <b>Type</b> | Pleated panel |
| <b>Dimensions</b> | H 594 x W 594 x d 95 |

New supply filter required urgently.

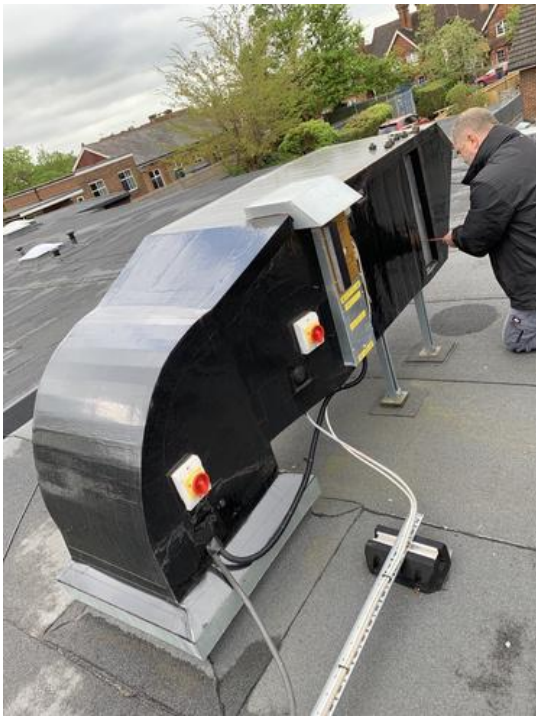
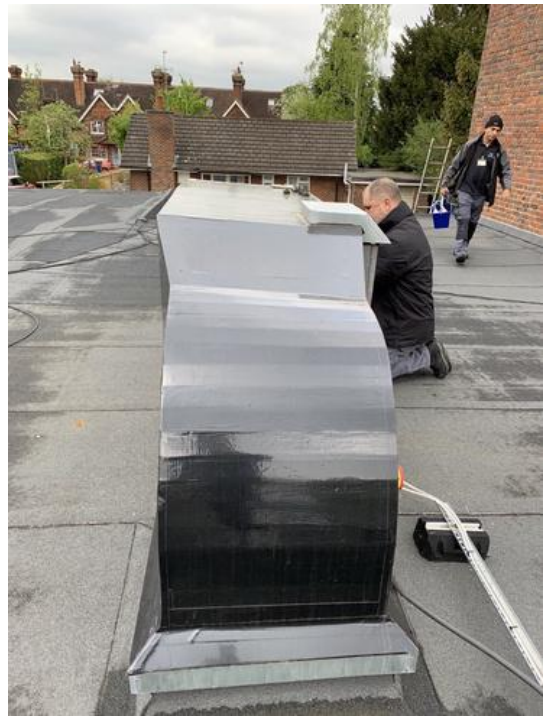
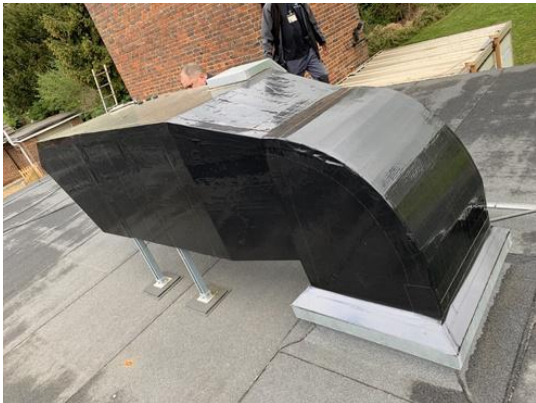
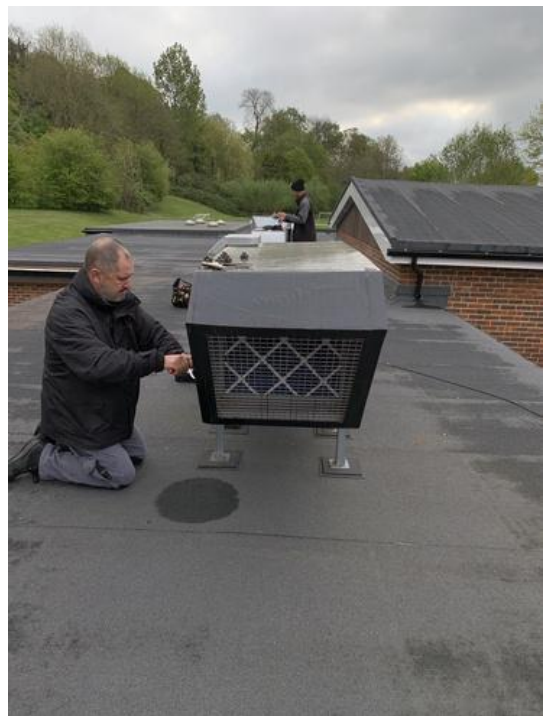
| <b>Condition?</b> | Good |

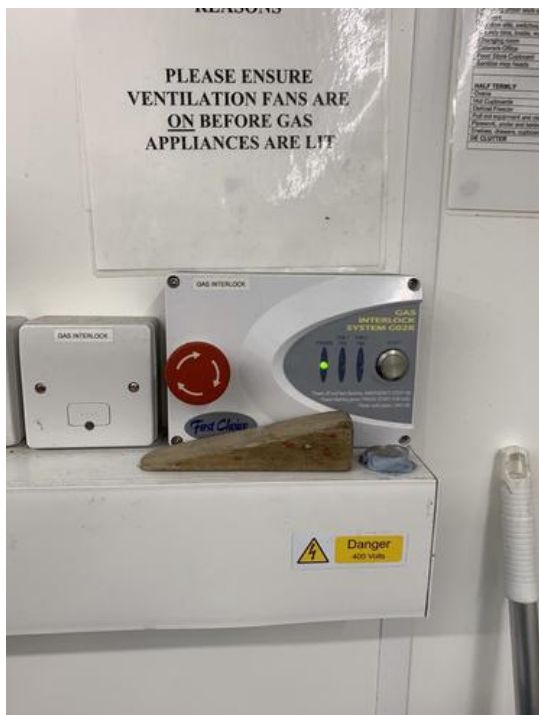
Photo 53

| <b>GAS INTERLOCK</b> | Yes |
| <b>Operation</b> | Pass |
