# Asbestos Reinspection Survey Report Nutfield Church Primary School 59 Midstreet South Nutfield

**Nutfield Church Primary School 59 Midstreet South Nutfield, Reinspection Survey**  
**Survey Date: 25 Sep 2024**  
**J068412, Report Issue v1**

J068412(1) 784-B067959.1.3  
25 Sep 2024

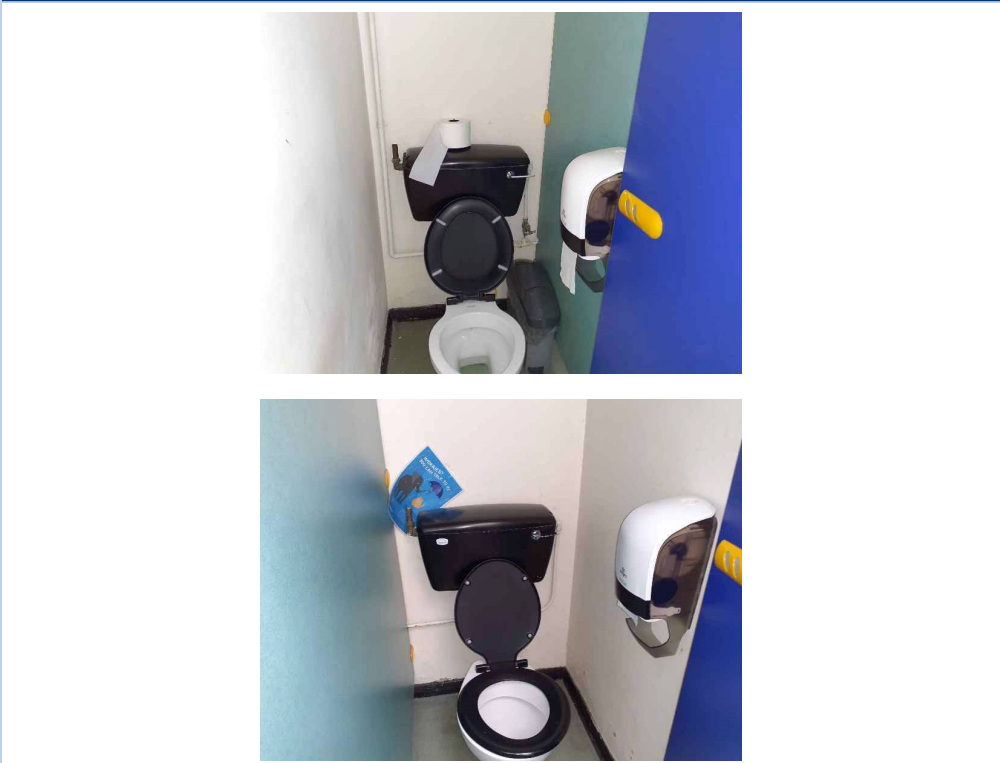
| Item Notes | No sample ref 6 - Strongly Presumed.<br>No Change |

| Extent of Damage | 1 |

| Recommendation | No Attention Required (Label and inspect at intervals) - Good/reasonable condition and adequately surface treated |

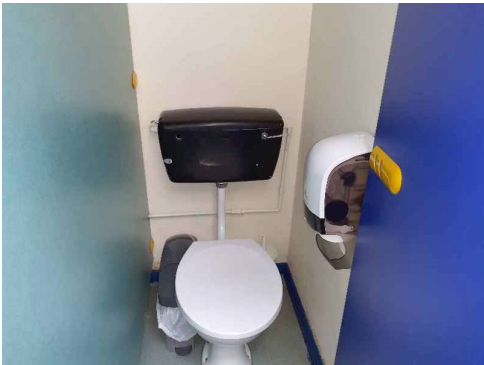
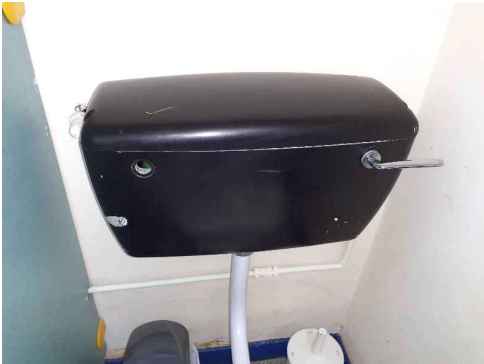
Item Notes    No Change

| Extent of Damage | 1 |

Recommendation    No Attention Required (Label and inspect at intervals) - Good/reasonable condition and adequately surface treated

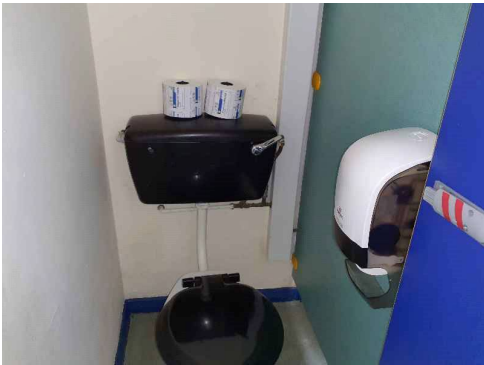
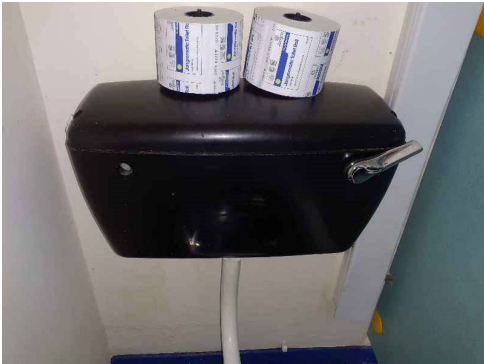
| Item Notes | No sample ref 2 - Strongly Presumed.<br>No Change |

| Extent of Damage | 1 |

| Recommendation | No Attention Required (Label and inspect at intervals) - Good/reasonable condition and adequately surface treated |

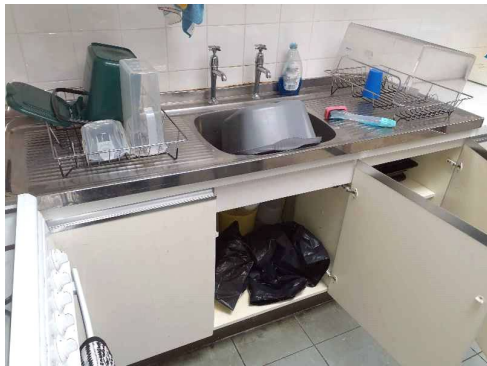
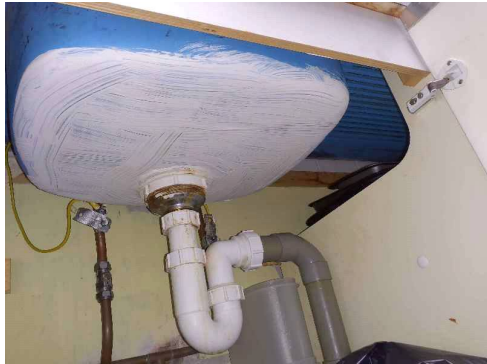
**Item Notes** Acoustic pads have been removed and encapsulated to underside of sink  
No Change  
Majority of sink pads removed 27.10.23 (Job No. J065726) with the remaining remnants encapsulated.

| Extent of Damage | 0 |

**Recommendation** No Attention Required (Label and inspect at intervals) - Good/reasonable condition and adequately surface treated

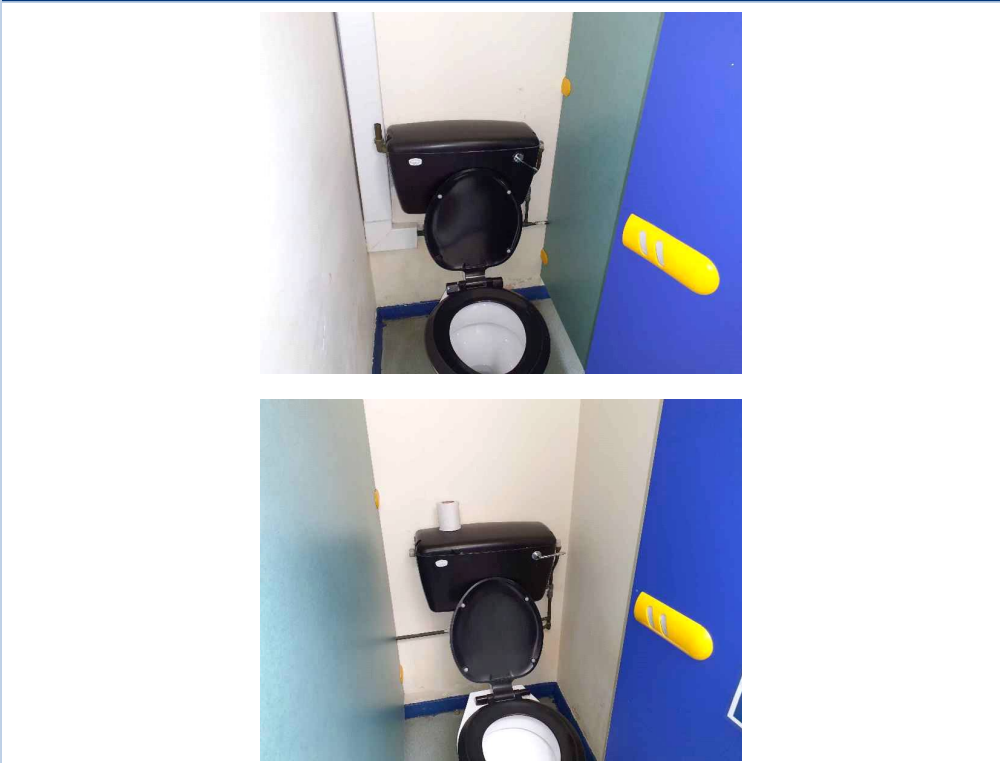
| Item Notes | No sample ref 13 - Strongly Presumed.<br>No Change |

| Extent of Damage | 1 |

| Recommendation | No Attention Required (Label and inspect at intervals) - Good/reasonable condition and adequately surface treated |

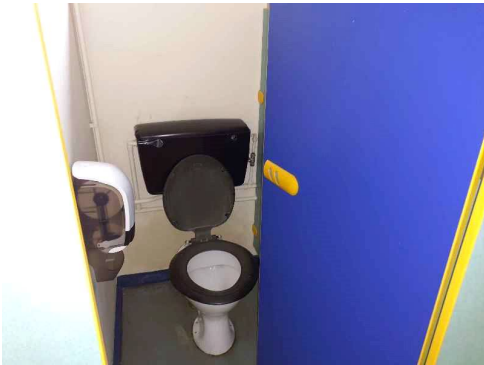
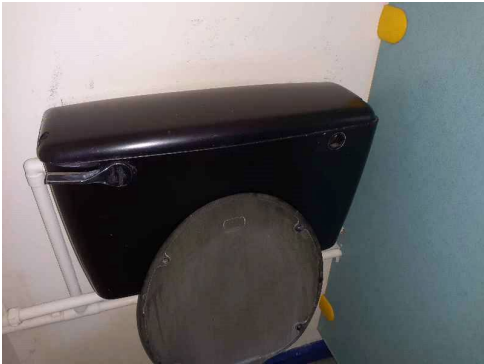
| Item Notes | No sample ref 17 - Strongly Presumed.<br>No Change |

| Extent of Damage | 1 |

| Recommendation | No Attention Required (Label and inspect at intervals) - Good/reasonable condition and adequately surface treated |
