# Asbestos Reinspection Survey Report Nutfield Church Primary School 59 Midstreet South Nutfield

Carried out on behalf of Surrey County Council by Tetra Tech Ltd

**Nutfield Church Primary School 59 Midstreet South Nutfield, Reinspection Survey**  
**Survey Date: 26 Sep 2025**  
**J072034, Report Issue v1**

J072034(1) 784-B067959.1.4  
26 Sep 2025

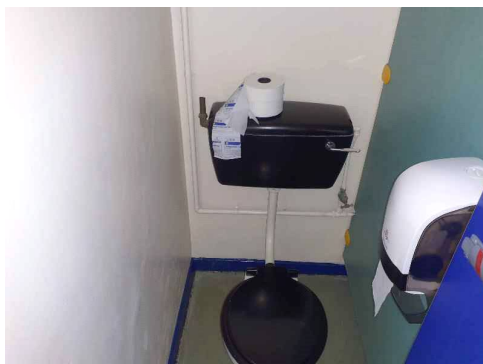
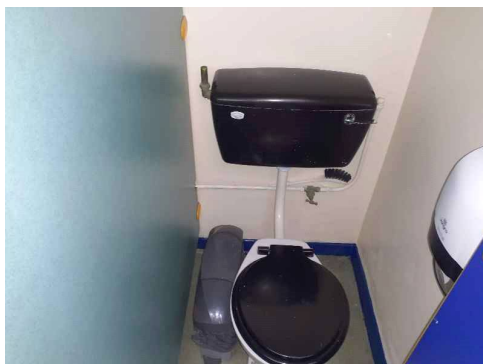
| Item Notes | No sample ref 6 - Strongly Presumed.<br>No Change |

| Extent of Damage | 1 |

| Recommendation | No Attention Required (Label and inspect at intervals) - Good/reasonable condition and adequately surface treated |

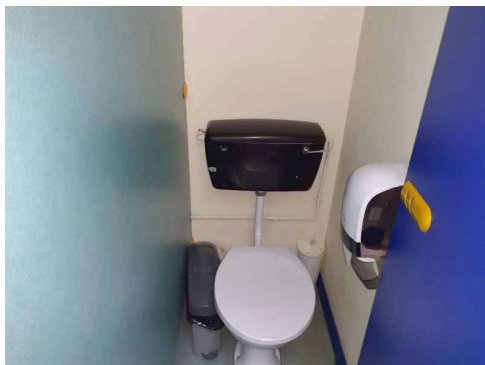
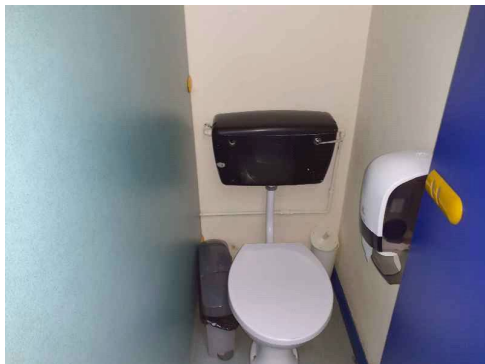
Item Notes No Change

| Extent of Damage | 1 |

**Recommendation** No Attention Required (Label and inspect at intervals) - Good/reasonable condition and adequately surface treated

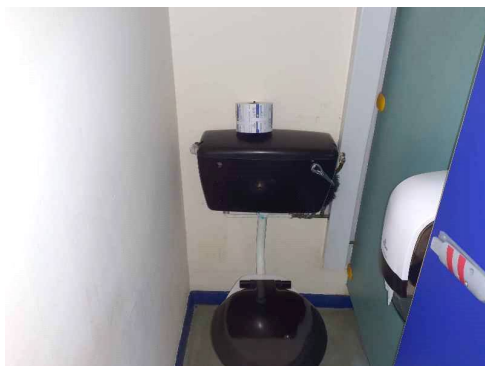
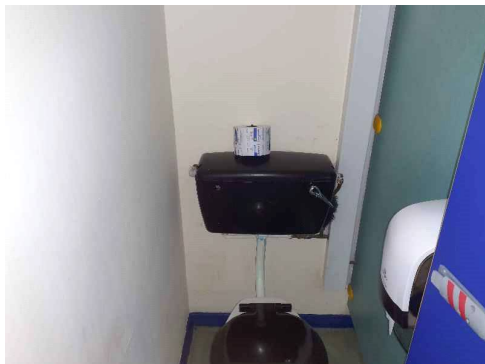
**Item Notes** No sample ref 2 - Strongly Presumed.  
No Change

| Extent of Damage | 1 |

**Recommendation** No Attention Required (Label and inspect at intervals) - Good/reasonable condition and adequately surface treated

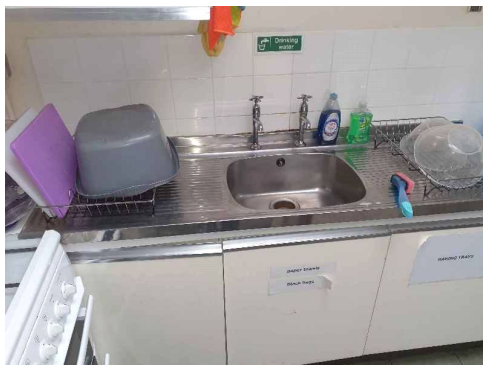
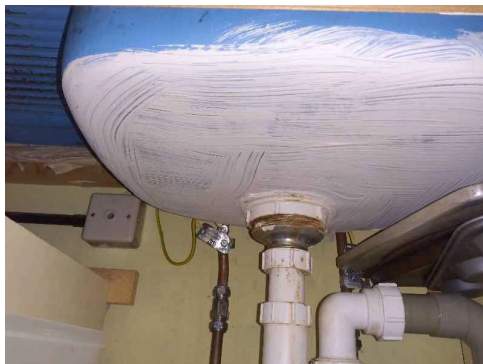
**Item Notes** Acoustic pads have been removed and encapsulated to underside of sink  
No Change  
Majority of sink pads removed 27.10.23 (Job No. J065726) with the remaining remnants encapsulated.

| Extent of Damage | 0 |

**Recommendation** No Attention Required (Label and inspect at intervals) - Good/reasonable condition and adequately surface treated

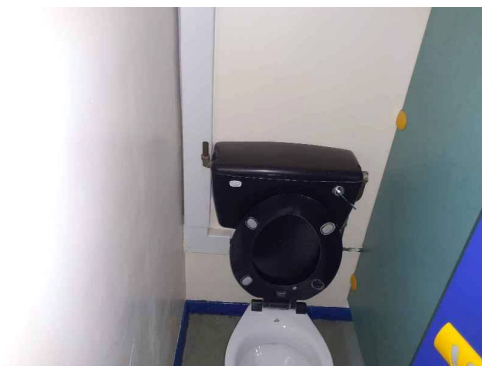
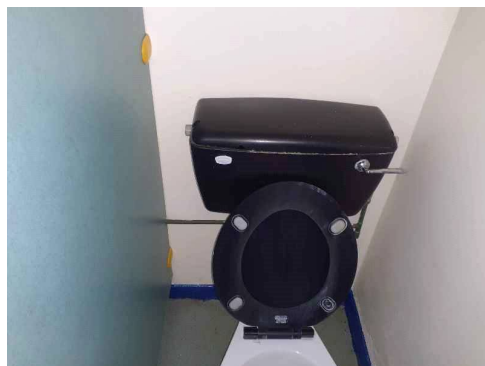
| <b>Item Notes</b> | No sample ref 13 - Strongly Presumed.<br>No Change<br>Small damage observed to cistern. Recommended to repair. 26/09/25 |

| Extent of Damage | 1 |

| <b>Recommendation</b> | No Attention Required (Label and inspect at intervals) - Good/reasonable condition and adequately surface treated |

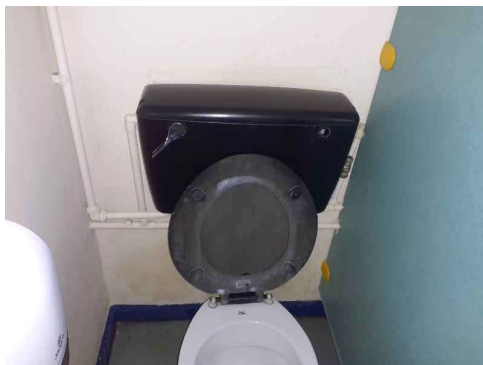
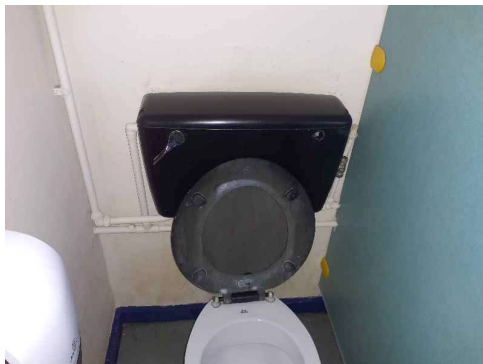
**Item Notes** No sample ref 17 - Strongly Presumed.  
No Change

| Extent of Damage | 1 |

**Recommendation** No Attention Required (Label and inspect at intervals) - Good/reasonable condition and adequately surface treated
