## Service Report for:

### **Nutfield Church (C of E) Primary School**

59 Mid Street  
South Nutfield  
Redhill  
Surrey  
RH1 4JJ

**BMS Service**

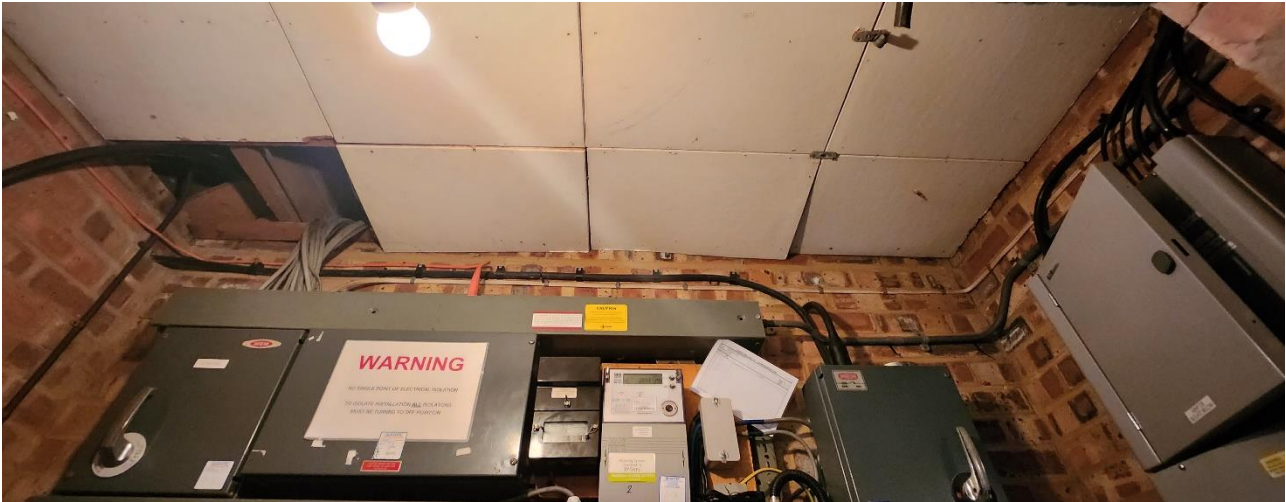
As much as this is not part of the BMS service, it was noted that no fire alarm heat/smoke detector, or fire alarm interface has been installed anywhere within the main boiler room or the adjacent electrical intake room, which is accessed through the boiler room. This is deemed a large safety risk as a fire breaking out in these areas would go unnoticed until the fire took hold, by which time may be too late. It would therefore be ***HIGHLY*** recommended that a fire alarm company is brought in and a heat detector installed in both the boiler room and the electrical intake room, along with a fire alarm interface which is linked to the BMS system so that the gas valve is shut in the event of a fire alarm activation – ***install fire alarm heat detectors in the boiler room and electrical intake room, and have a fire alarm interface installed to integrate with the BMS panel so that the gas valve is shut down when the fire alarm is activated.***

- No heat/smoke detector in the electrical intake cupboard

1. Replace blown panel lamp with new
2. Lower ETL above burner to no more than 300mm distance
3. Get fire alarm company to install fire alarm heat detectors in the boiler room and electrical intake room, and have a fire alarm interface installed to integrate with the BMS panel so that the gas valve is shut down when the fire alarm is activated.

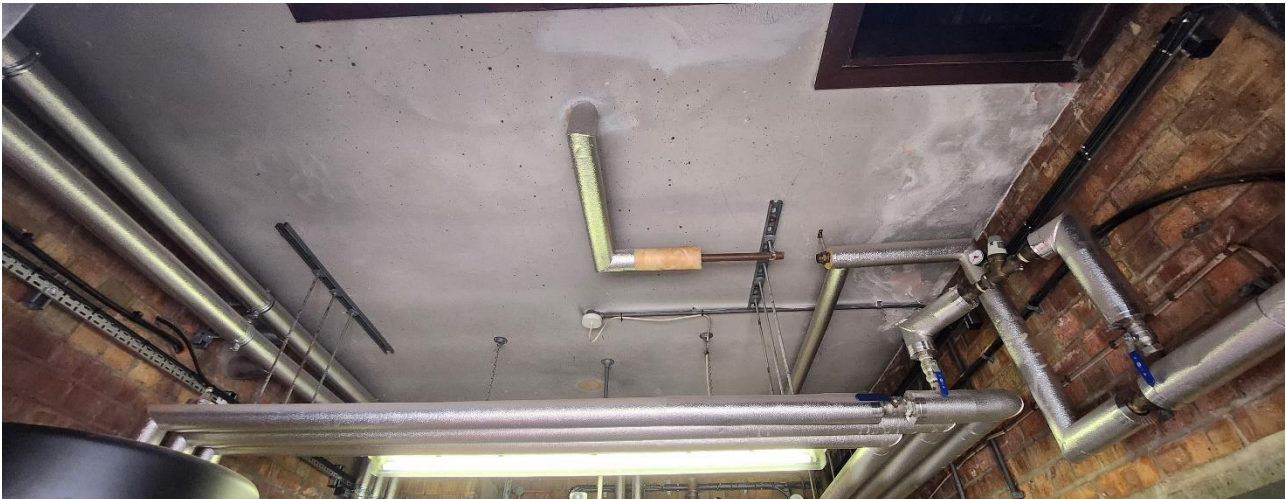
- No heat/smoke detector in the boiler room
