## LEGIONELLA RISK ASSESSMENT REPORT FOR NUTFIELD CHURCH PRIMARY SCHOOL UPRN:874

| Report Number: | R_3,604 |
| Survey Date: | 07-09-2022 |

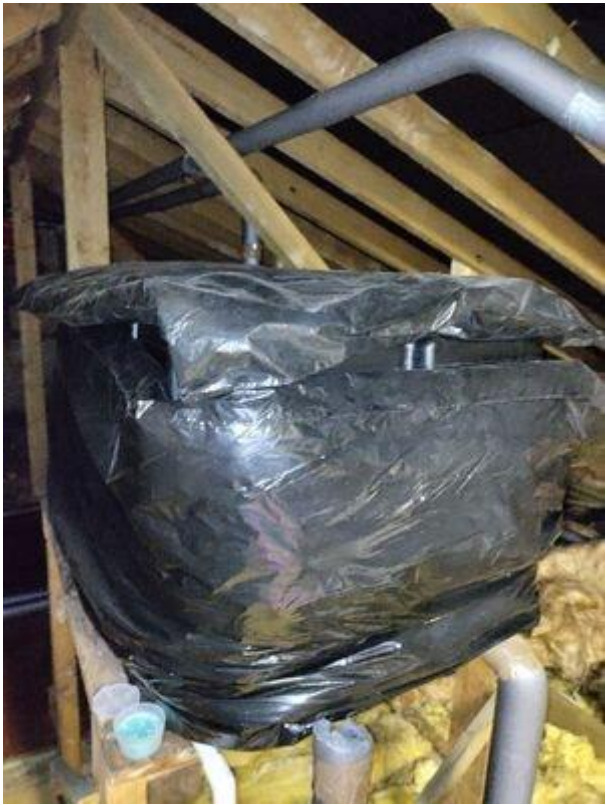
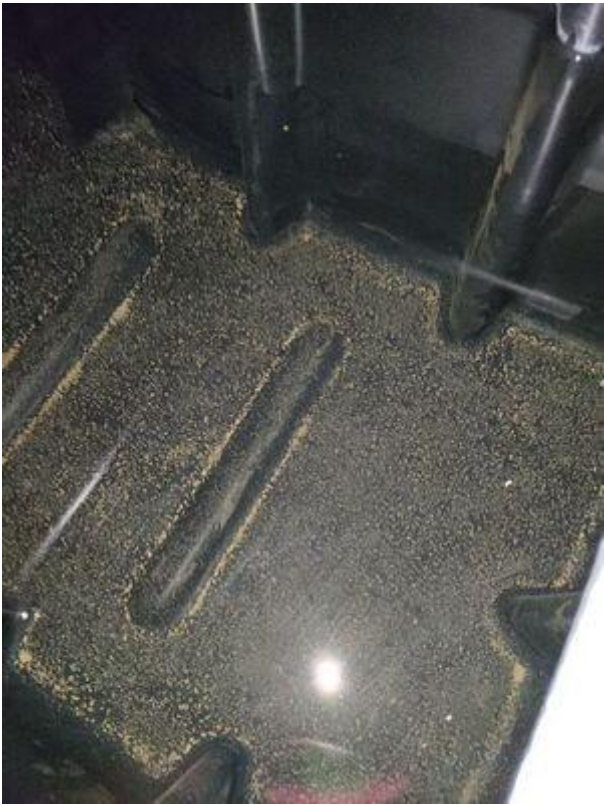
**CWST\_000001 COLD WATER STORAGE TANK** [🔗](#)  
2 / CARETAKERS BUNGALOW- LOFT SPACE

| Internal Condition<br><b>Guidance:</b> Continue to monitor throughout the year and if internal condition worsens, clean and disinfect the cold water storage tank removing all sediment and possible contaminants. | Light Sediment (20% coverage within tank) | 3 | |

CWST external

CWST internal

| Continue to monitor throughout the year and if internal condition worsens, clean and disinfect the cold water storage tank removing all sediment and possible contaminants.<br>CWST_000001 | 3 | 1 | 07-09-2023 | | |

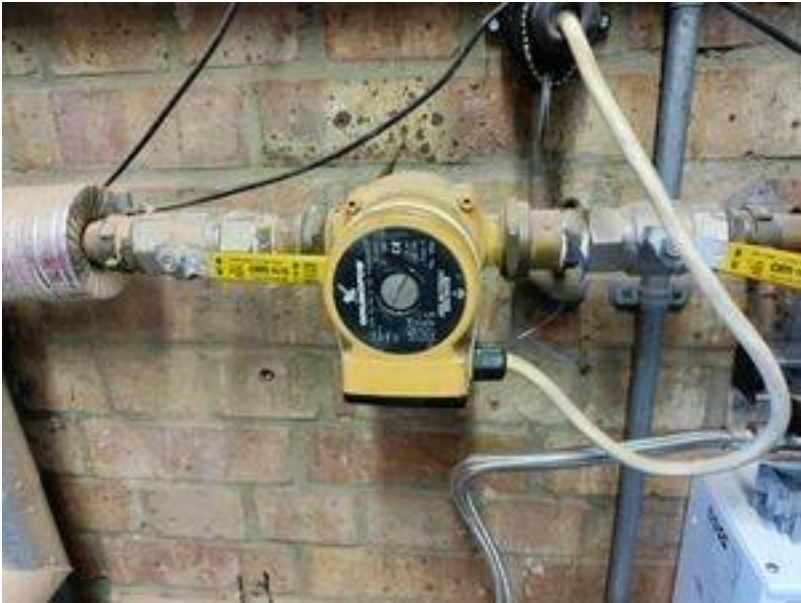
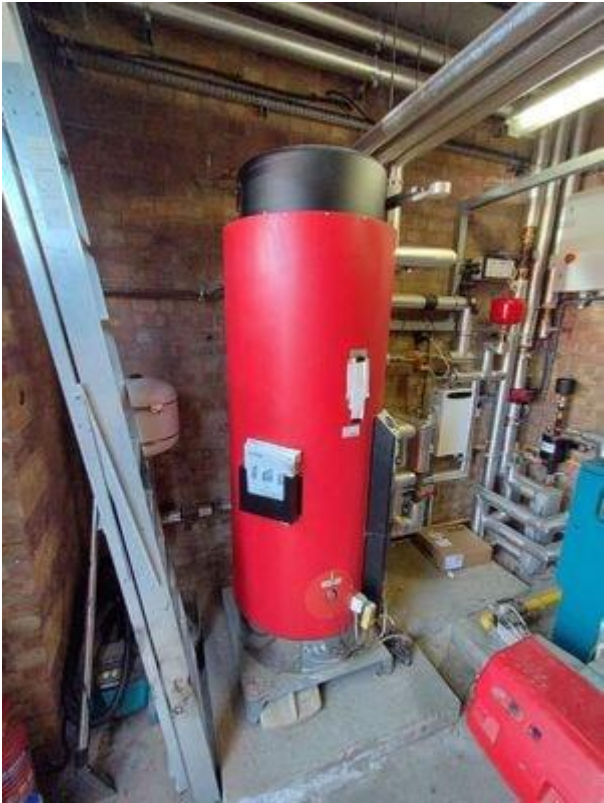
**Q** / SCHOOL / GROUND FLOOR / EXTERNAL PLANT ROOM / CAL01

| Is adequate backflow protection fitted to the water heater?<br><i>Guidance: We recommend a double check valve is installed for suitable backflow prevention.</i> | No | | 3 |

return Pump

CAL01

| We recommend a double check valve is installed for suitable backflow prevention.<br>CAL_000001 | 3 | 1 | 07-09-2023 | | |

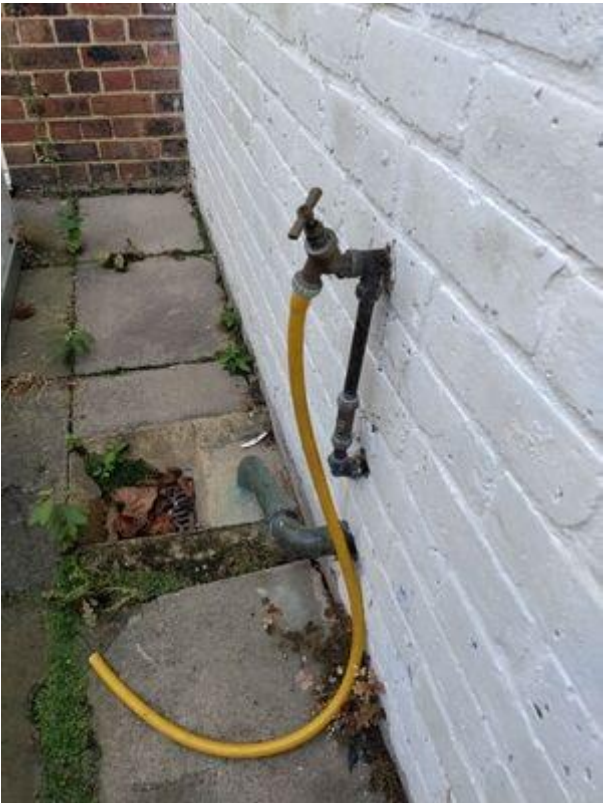
*Asset Identifiers:*  
*Site Asset Number:* Bib Tap01  
*Type:* Full Turn  
*Condition of outlet?:* Good Condition  
*Is there scale on the outlet?:* No Scale  
*Is this outlet a sentinel?:* No  
*What is this outlet fed by?:* Mains  
*Is this outlet a dead leg? e.g. infrequently/never used:* No - Outlet used or flushed within a 7 day period  
*Is there a significant spray potential present?:* No  
*Is there a double check valve or internal back flow fitted or air gap present if supplied via a Cold Water Storage Tank?:* Yes  
*Is the bib tap installed in a bin store or around conditions that would warrant category 5 air gap protection?:* Yes (category 5 air gap not present)

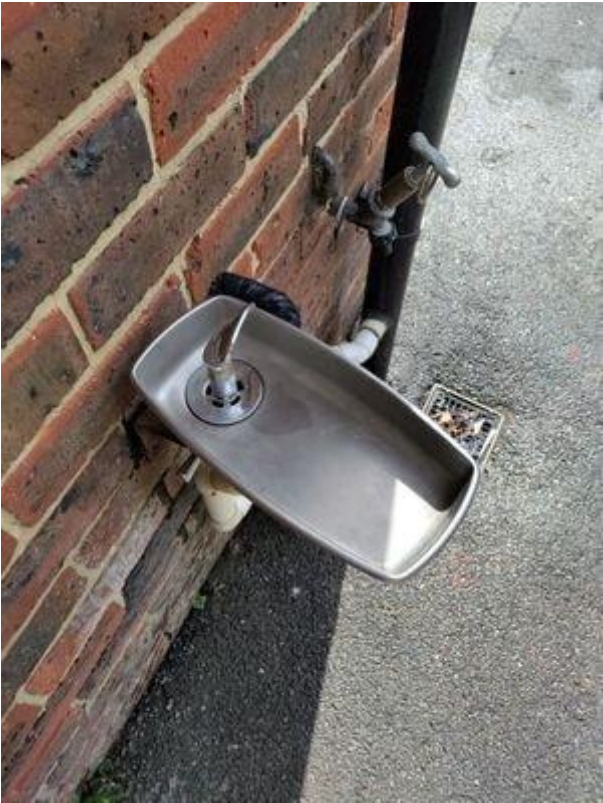
*Asset Identifiers:*  
*Site Asset Number:* Drinking Fountain  
*Type:* Lever  
*Condition of outlet?:* Good Condition  
*Is there scale on the outlet?:* Light Scale  
*Is this outlet a sentinel?:* No  
*What is this outlet fed by?:* Mains  
*Is this outlet a dead leg? e.g. infrequently/never used:* No - Outlet used or flushed within a 7 day period  
*Is there a significant spray potential present?:* No

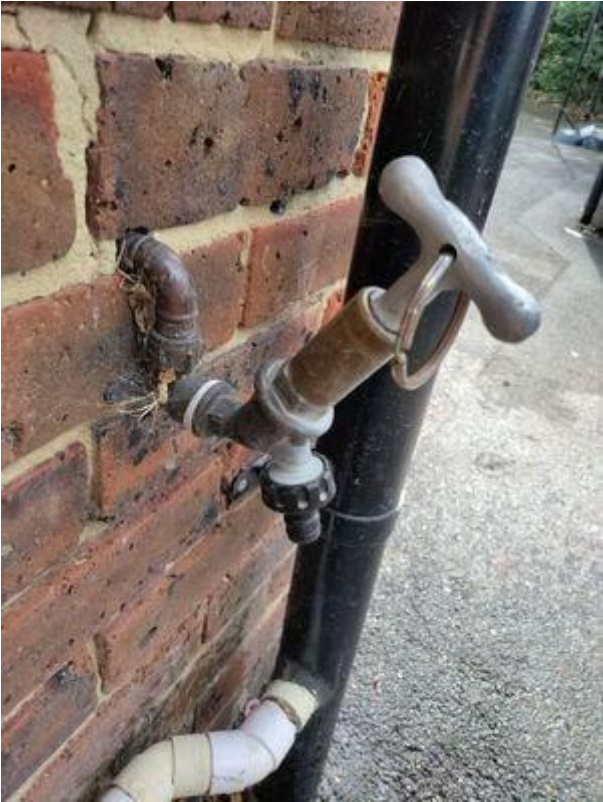
Bib Tap02

| <div><div><div>HWO_000009</div><div>OUTLET: HOT WATER</div></div><div><div>📍</div><div>SCHOOL / GROUND FLOOR / YEAR 3 CLASS / SINK</div></div></div> <div><div>Asset Identifiers:</div><div>Condition of outlet?: Good Condition</div><div>Is there scale on the outlet?: No scale</div><div>Is this outlet a sentinel?: Yes</div><div>Type of sentinel: Furthest Hot (FH)</div><div>Is the outlet a mixer tap?: No</div><div>Is the outlet fed by a TMV?: Yes</div><div>Is this outlet a dead leg? e.g. infrequently/never used: No - Outlet used or flushed within a 7 day period</div></div> | | |

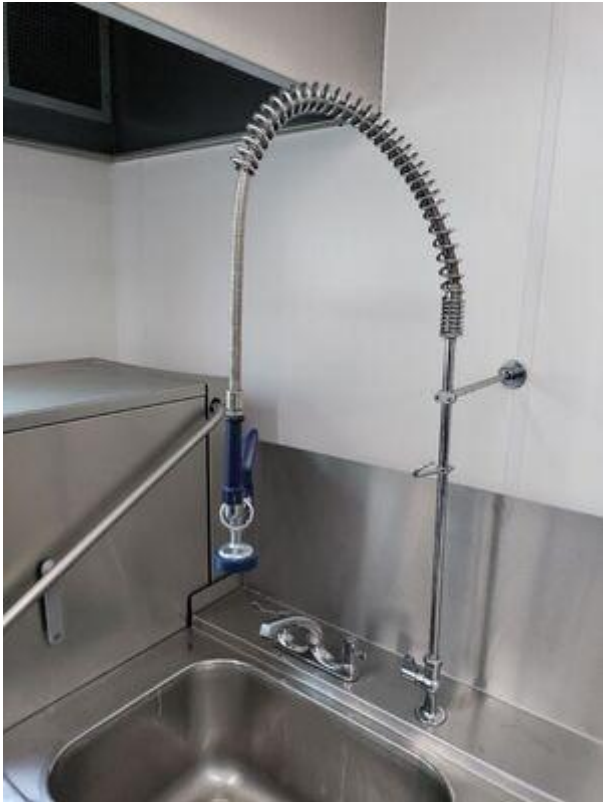
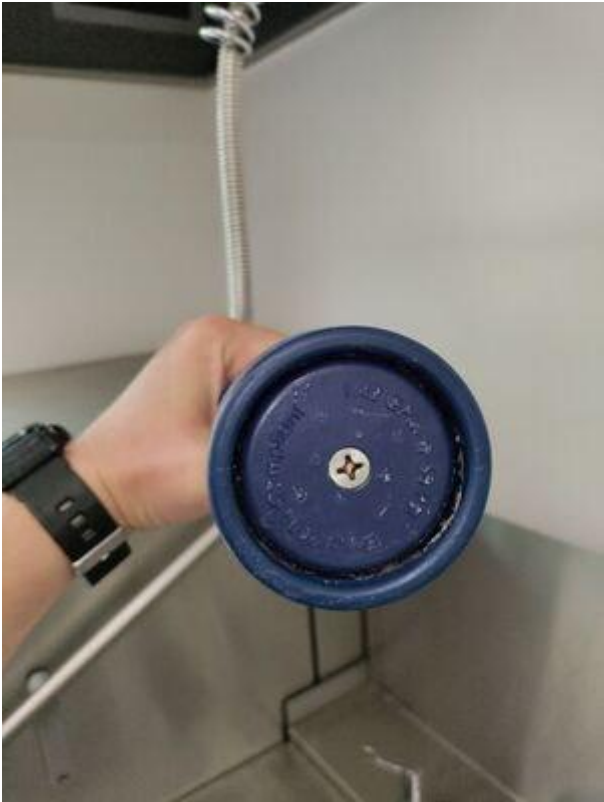
**SH\_000001** **SHOWER** [🔗](#)  
Q / SCHOOL / GROUND FLOOR / KITCHEN /

*Asset Identifiers:*  
*Make:* Unknown  
*Model:* Unknown  
*Type:* Cold Only  
*Is there backflow prevention installed?:* No  
*Is this shower a dead leg? e.g. Infrequently/Never used.:* Yes  
*Is the flexible hose long enough to make contact with the shower tray?:* No  
*Condition of the shower head:* Heavy Scale

Pot Wash Spray Head

| The shower is infrequently used therefore considered a dead leg. We recommend it is removed from the system if no longer in use or alternatively the outlet is flushed on a weekly basis with records kept until it is put back into normal use or removed from the system.<br><b>SH_000001</b> | 9 | 1 | 07-12-2022 | | |

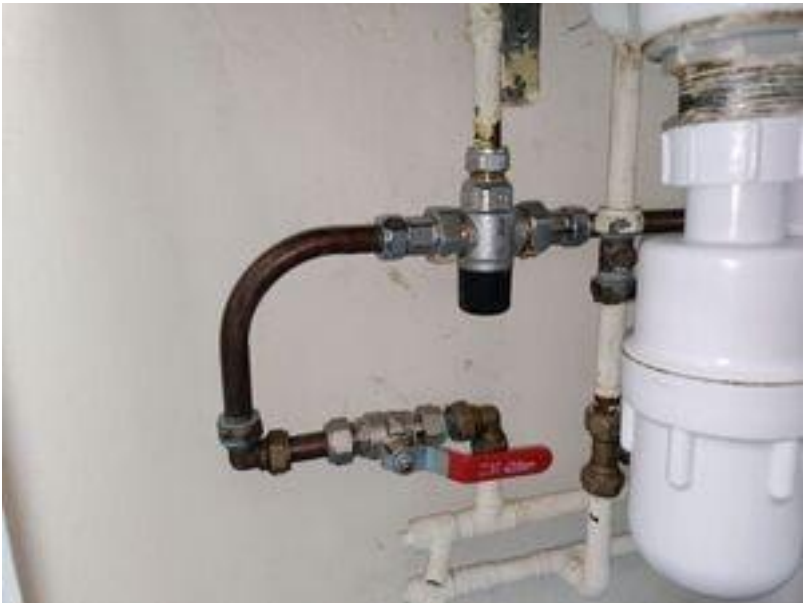
**TMV\_000013** THERMOSTATIC MIXING VALVE (TMV) [🔗](#)  
🚻 / SCHOOL / GROUND FLOOR / STAFF LADIES TOILET / LHS BASIN

Asset Identifiers:  
Make: Unknown  
Is the TMV accessible?: No

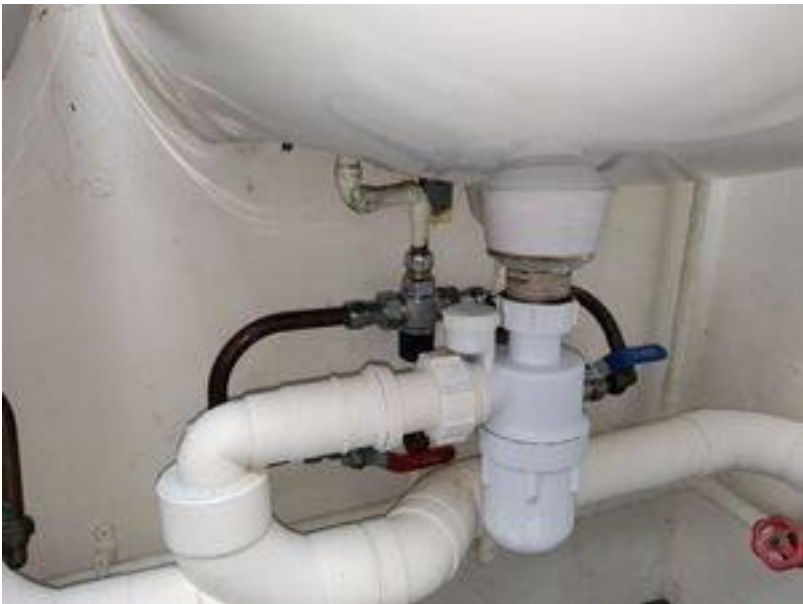
**TMV\_000014 THERMOSTATIC MIXING VALVE (TMV)** [🔗](#)  
📍 / SCHOOL / GROUND FLOOR / STAFF LADIES TOILET / RHS BASIN

*Asset Identifiers:*  
*Make:* Unknown  
*Is the TMV accessible?:* No

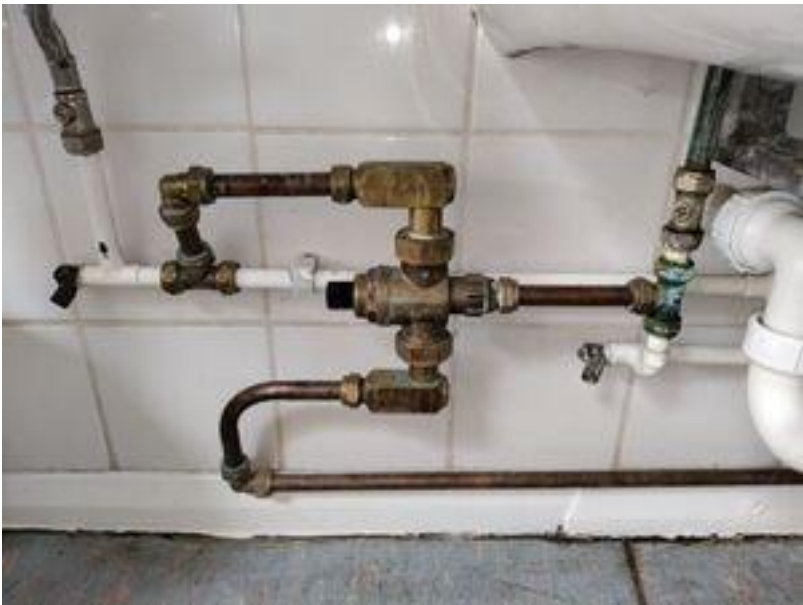
**TMV\_000001 THERMOSTATIC MIXING VALVE (TMV)** [🔗](#)  
📍 / SCHOOL / GROUND FLOOR / RECEPTION CLASS /

*Asset Identifiers:*  
*Make:* Horne  
*Is the TMV accessible?:* Yes  
*Model:* Unknown  
*Size:* 15 mm  
*Condition:* Good  
*Does the TMV feed more than one outlet?:* Yes  
*How many outlets does the TMV feed?:* 2 No.  
*How far away from the outlet is the TMV?:* Less than 2m away from the outlet  
*Is the hot supply to this TMV fed solely from an unblended source?:* Yes

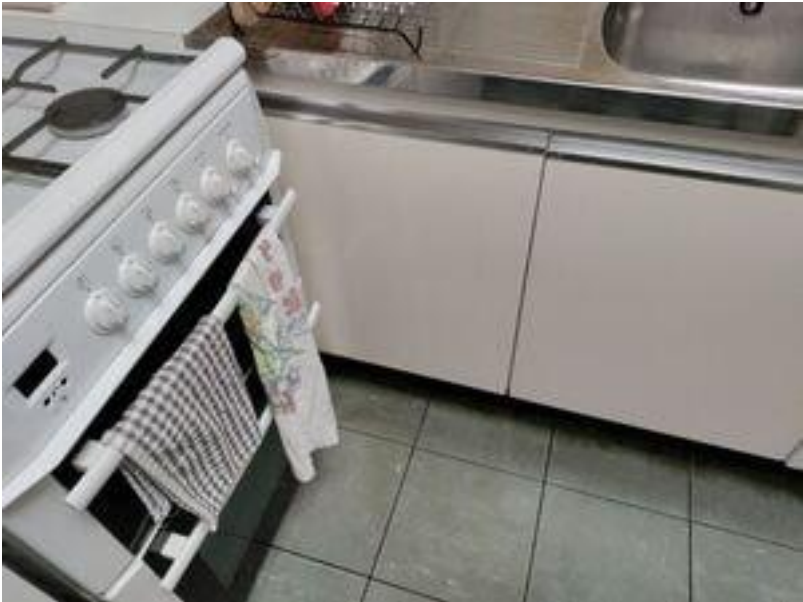
**TMV\_000011 THERMOSTATIC MIXING VALVE (TMV)** [↗](#)  
📍 / SCHOOL / GROUND FLOOR / FOOD TECH / SINK REAR

*Asset Identifiers:*  
*Make:* Unknown  
*Is the TMV accessible?:* No  
*General comment/s:* TMV behind panel in LHS sink unit

TMV behind panel in LHS sink unit

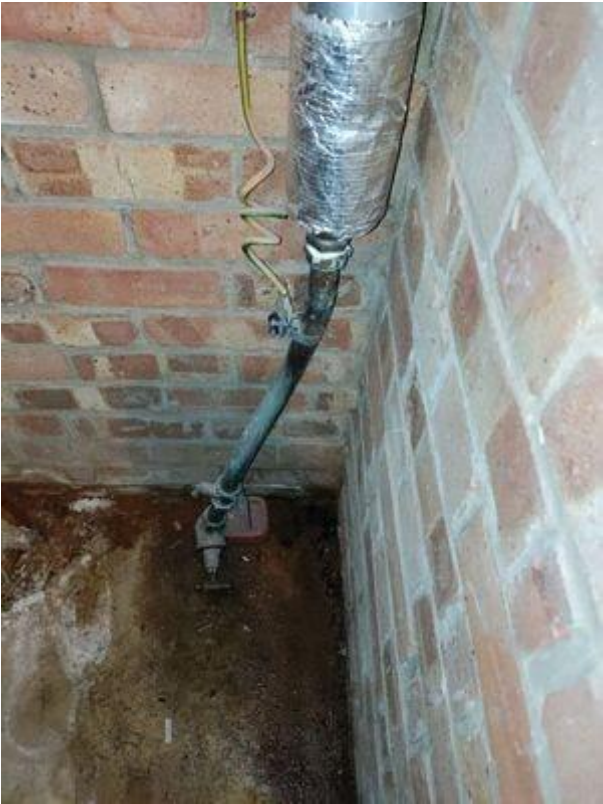
**MSC\_000001** MAINS STOP COCK [🔗](#)  
📍 / SCHOOL / GROUND FLOOR / EXTERNAL PLANT ROOM /

*Asset Identifiers:*  
*Has mains stop cock been located?:* Yes  
*Site Asset Number:* MSC01  
*Size:* 28 mm  
*Material:* Copper  
*Is the local pipework insulated?:* No  
*Isolation available and working?:* Unable to determine

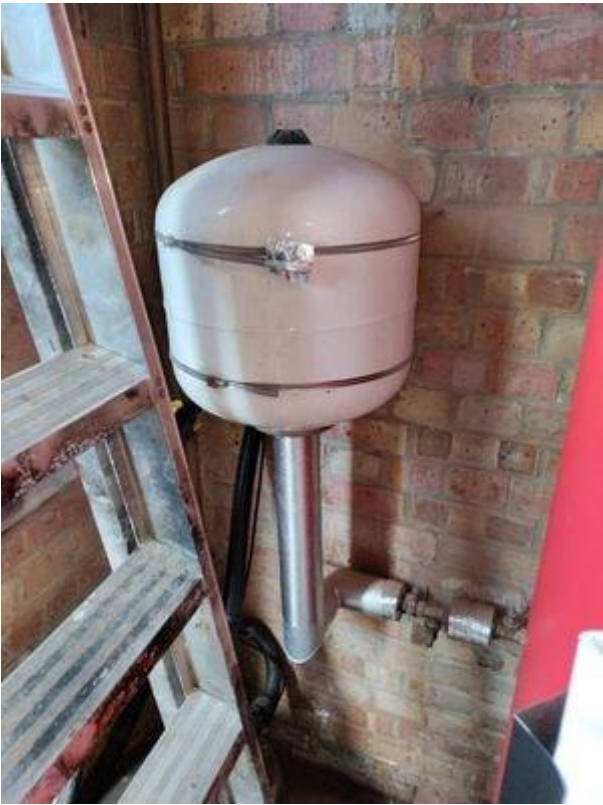
EXP01

Is the vessel fit on a pipework sump?: No

Is the vessel a domestic potable approved pressure vessel?: Yes

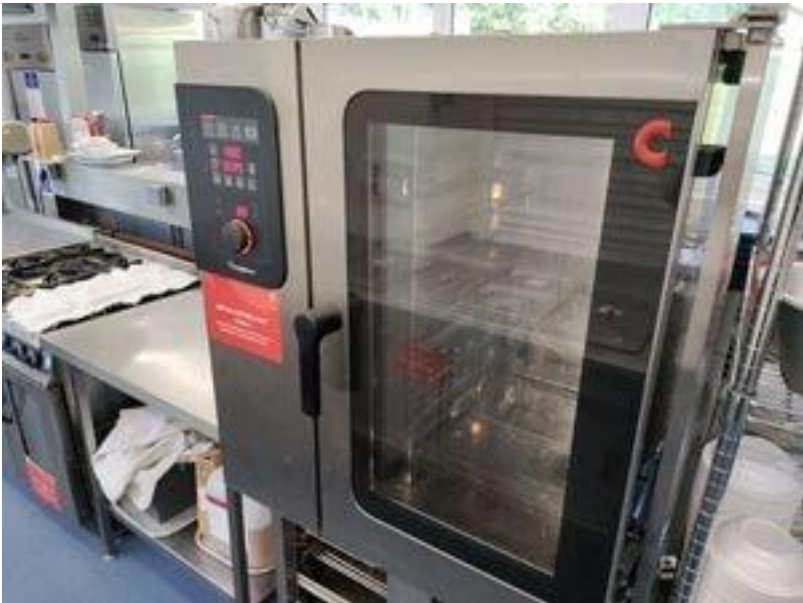
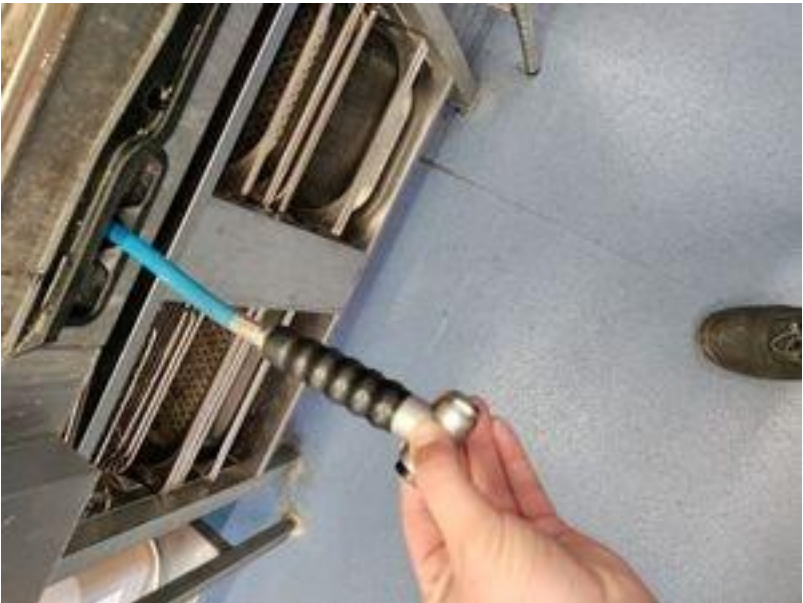
STEAMOV\_000001 STEAM OVEN [↗](#)

Steam Oven

Spray Head

| We recommend a double check valve is installed for suitable backflow prevention.<br><a href="#">STEAMOV_000001</a> | 3 | 1 | 07-09-2023 | | |

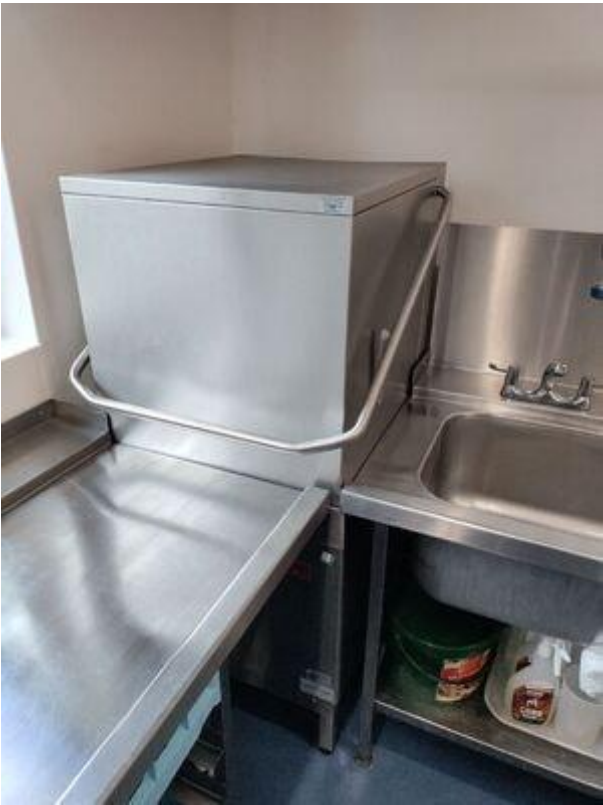
| <div><div></div><div>Dish Washer</div></div> | | |

| Is adequate backflow protection fitted? | Unable to determine | |

| <div><div>DISHW_000002</div><div>DISHWASHER <a href="#">↗</a></div><div>♀ / SCHOOL / GROUND FLOOR / KITCHEN /</div></div> | | |

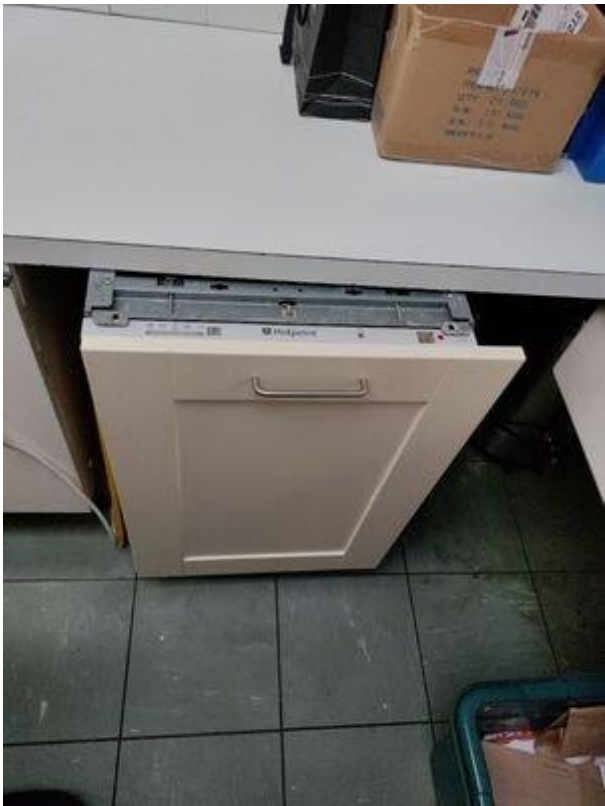
Dish Washer

| <div><div>DISHW_000001</div><div>DISHWASHER <a href="#">↗</a></div><div>♀ / SCHOOL / GROUND FLOOR / FOOD TECH /</div></div> | | |
| Is adequate backflow protection fitted? | Unable to determine | |

**DISHW\_000001** **DISHWASHER** [↗](#)  
📍 / SCHOOL / GROUND FLOOR / FOOD TECH /
