## Service Report for:

### **Nutfield Church (C of E) Primary School**

**BMS Service**

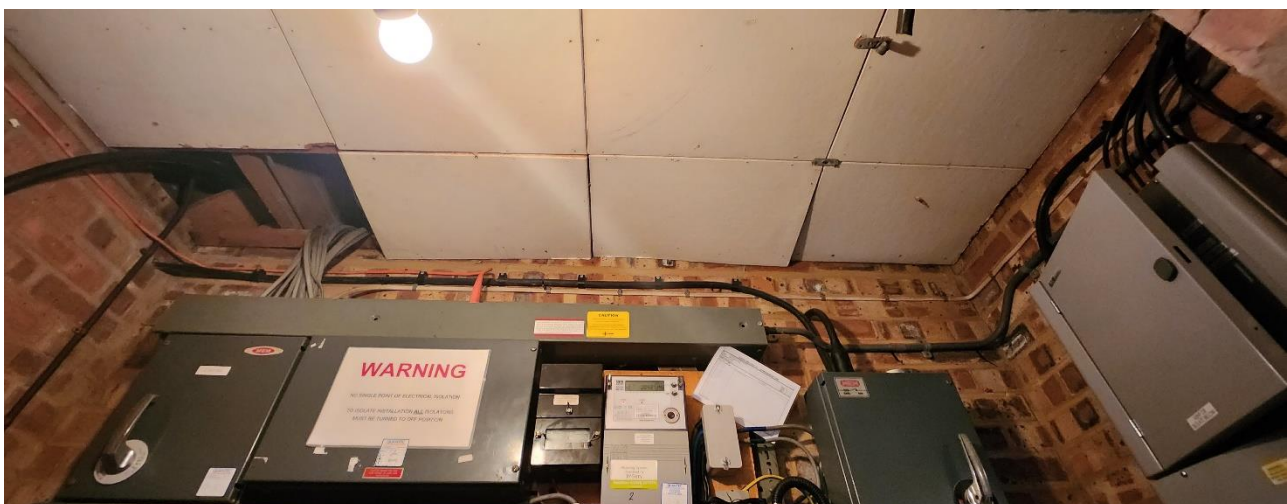
As much as this is not part of the BMS service, it was noted that no fire alarm heat/smoke detector, or fire alarm interface has been installed anywhere within the main boiler room or the adjacent electrical intake room, which is accessed through the boiler room. This is deemed a large safety risk as a fire breaking out in these areas would go unnoticed until the fire took hold, by which time may be too late. It would therefore be ***HIGHLY*** recommended that a fire alarm company is brought in and a heat detector installed in both the boiler room and the electrical intake room, along with a fire alarm interface which is linked to the BMS system so that the gas valve is shut in the event of a fire alarm activation – ***install fire alarm heat detectors in the boiler room and electrical intake room, and have a fire alarm interface installed to integrate with the BMS panel so that the gas valve is shut down when the fire alarm is activated.***

- No heat/smoke detector in the electrical intake cupboard

1. This was identified on the previous service and has yet to be rectified. This is a safety risk and needs to be actioned! A fire alarm company needs to install heat detectors in the boiler room and electrical intake room and have a fire alarm interface installed to integrate with the BMS panel so that the gas valve is shut down when the fire alarm is activated.

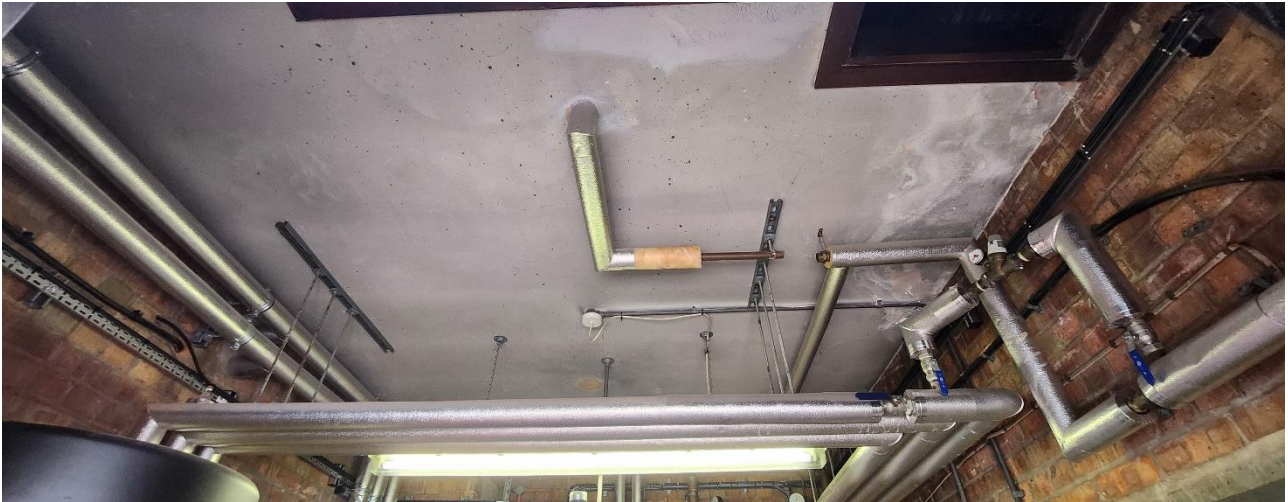
- No heat/smoke detector in the boiler room
